Senior Design Project

Final Report

The University of Toledo Ottawa River Restoration

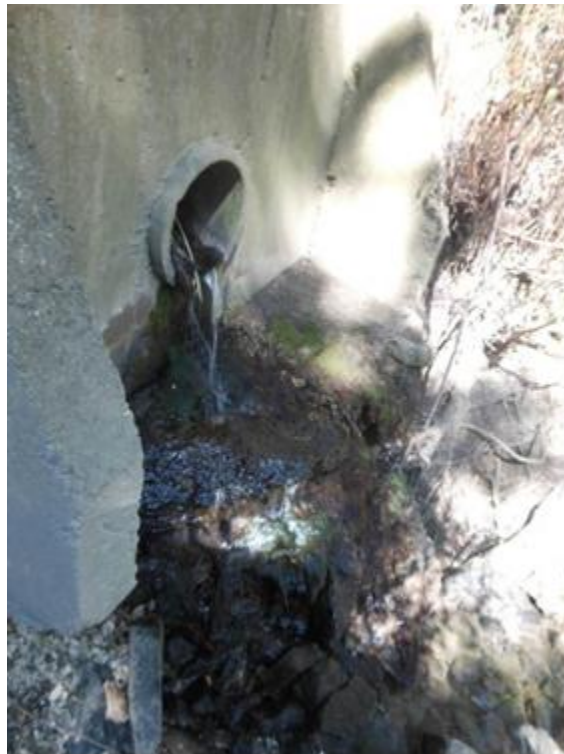
Figure 3 – Outfall #1 Channel

Outfall #1 is located in Reach 3 on the North side of the Ottawa River, between the pedestrian bridges by the Center for Performing Arts and the Carlson Library, just off the access path. There is no vegetation where this outfall is located. There is little damage to the headwall itself, but soil has eroded from underneath the headwall structure on its western side. Also, the splash pad has broken off on the westernmost side of the outfall. The erosion has caused some of the toe of the headwall to break away (Figure 3). Outfall #1 has steep banks that lack stability resulting in the erosion. The outfall does not have a very lengthy channel run. There is rip-rap at the base of the outfall, but there is little protection of the banks around the outfall. Dimensions of the current headwall are 67” tall, 82” wide, and 36” deep. This outfall utilizes a 14” diameter pipe.

At Outfall #1, a proposed alternative and recommended solution is to repair the headwall of the structure. To repair the erosion from the structure, first the broken splash pad should be removed from the outfall. Some of the loose soil and any obstructions should be removed from around the area where the erosion concern is an issue. Next, rip rap should be placed and compacted to shore up the headwall structure. A new concrete splash pad should be poured at the

Another proposed alternative is to remove and replace the entire headwall structure at Outfall #1. This option eliminates the damaged areas to the headwall. Many headwalls are precast concrete structures, so they can be purchased at reasonable cost. The pipe associated with this headwall is 14" in diameter. The cost of the new precast headwall needed for this size of pipe is \$495.00 as priced from Oldcastle Precast Headwalls. Figure 4 depicts the new headwall.

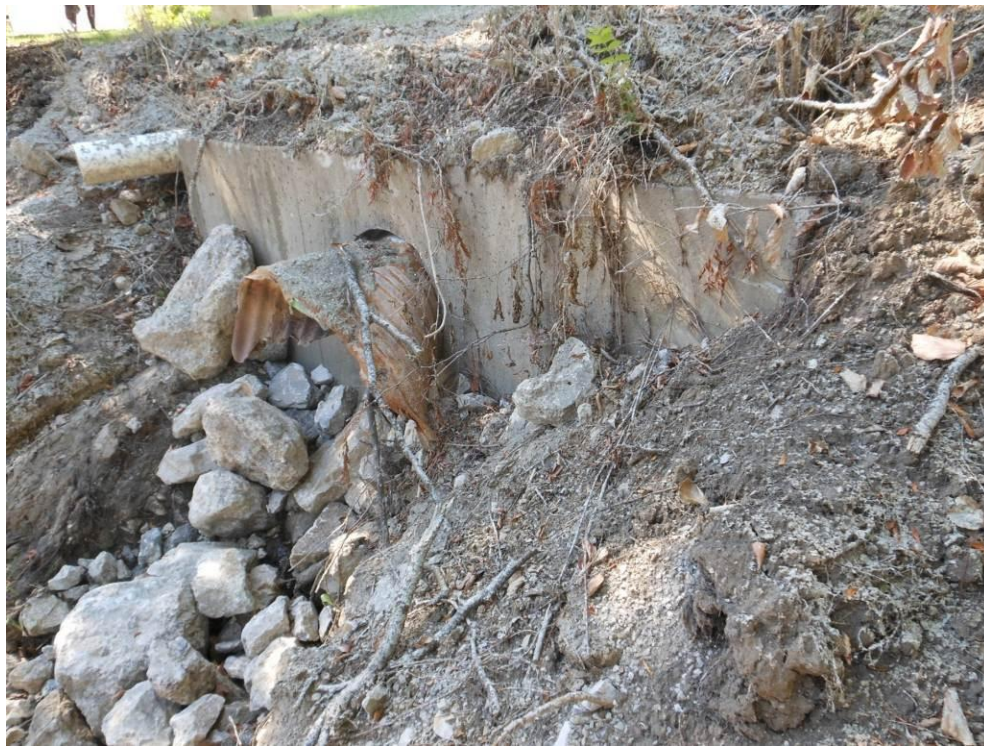
Figure 6 – Outfall #2 Erosion

The concrete headwall seems to be in working condition. It is serving its purpose of holding back the earth around it. The corrugated metal pipe has been damaged, presumably from recent construction work performed during the river restoration (Figure 6). The channel consists of eroded soil on the banks with various sizes of rocks in the middle of the channel to help dissipate the flow with the large elevation difference between the outfall and the water level.

The existing erosion issues are due to the steep slope around the outfall. Removal of vegetation around the outfall also has increased the erosion concerns. The channel is in need of reconstruction due to the dangerous erosion issues and the absence of efficient bank stabilization. More details on channel alternatives will be addressed in a separate section of the scope.

A proposed alternative to address this headwall is to modify the damaged section of pipe. To do this, the damaged section of the pipe that extends out of the headwall should be cut off. The pipe will then be flush with the headwall. This approach will keep the headwall as is, without a need to replace or move the headwall. A replacement alternative was not implemented since the headwall is in relevantly good condition.

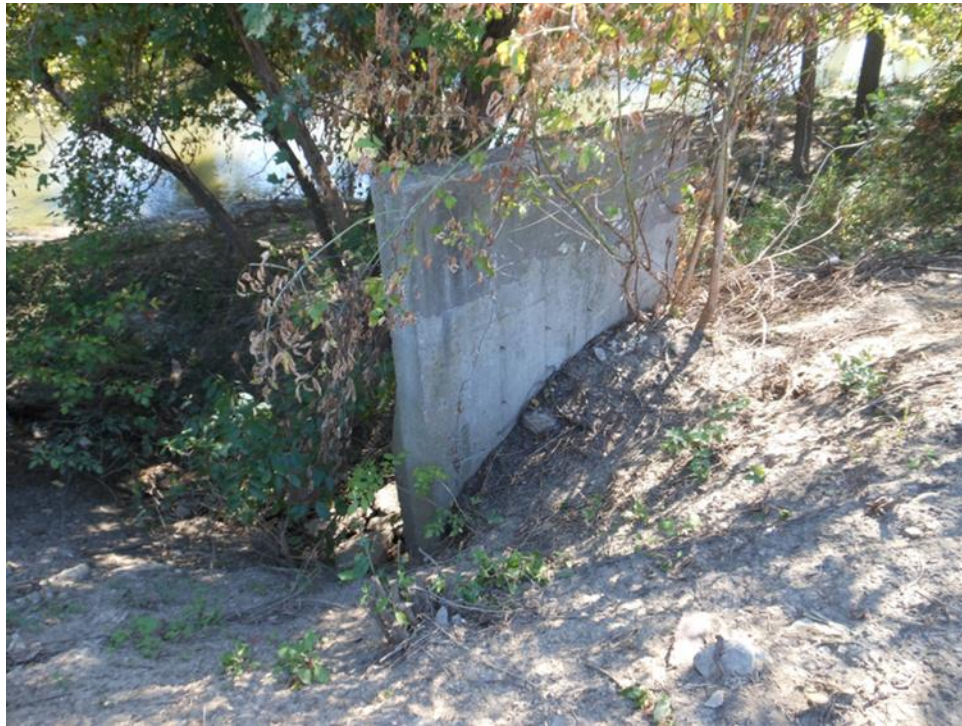
Figure 9 – Erosion around Headwall #3

Outfall #3 is located on the North side of the Ottawa River in Reach 4, near the Health and Human Services Building (Figure 9). It is observable when driving East on North Towerview Boulevard to the right on the bank of the river. The headwall of the outfall is sized at 134" tall, 80" wide, and 12" deep. The headwall currently sits approximately 25 feet from the dry weather water level. The headwall also is located approximately eight feet from North Towerview Blvd. The current pipe coming from the outfall is a 21" concrete pipe. The bank around the outfall consists of a moderate slope with hazardous erosion issues on each side of the outfall.

The concrete pipe in the headwall has no damage and has accessible flow into the channel. The channel consists of a small path worn into the soil from the small flow of water. The concrete headwall is in relatively good shape. The headwall extends out of the ground significantly due to erosion caused by the removal of the various trees and bushes that were originally around the outfall (Figure 9). The massive headwall is no longer needed due to the erosion issues. The headwall is also currently leaning forward. There is no form of channel stabilization to restrict the flow path of the water.

Another proposed alternative to address the enormous, unappealing headwall is by removing and replacing it with a new one. This will allow for more opportunity to deal with the erosion issues. A smaller, more appropriately sized headwall could then be installed for the outfall, while incorporating the existing concrete pipe in the headwall itself. A new headwall would also eliminate the forward lean of the existing headwall. Though this lean is minimal, the headwall could continue to settle; therefore, amplifying the lean. The pipe associated with this headwall is 21” in diameter. The cost of the new precast headwall needed for this size of pipe is \$605.00 as priced from Oldcastle Precast Headwalls. Figure 10 depicts the new headwall.

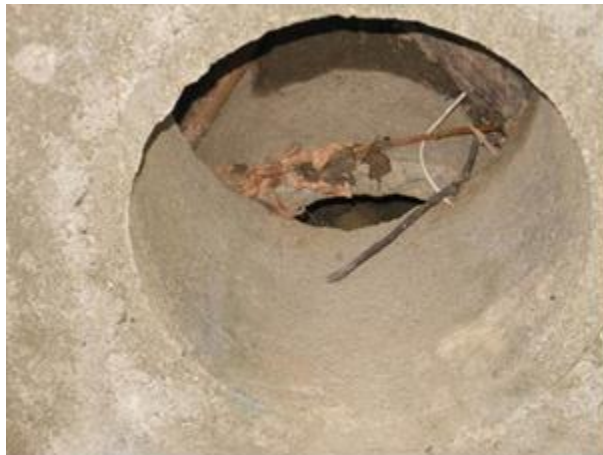
Figure 11 – Settled Pipe Inside Headwall #4

Outfall #4 is located in Reach 5 on the North side of the Ottawa River, South of the Health and Human Services Building. This outfall sits 8 feet south of the curb along North Towerview Boulevard. Outfall #4 is in poor condition. Inside the headwall, the pipe had settled, disconnecting itself from the headwall. As a result, the pipe no longer lines up with the headwall's outlet as shown in Figure 11. Soil on the top side of the headwall has, overtime washed out due to the separated pipe carrying the earth away and exposed the back side of the headwall. There is severe erosion along the side of the headwall as well, due to poor bank stabilization as seen in Figure 12. Outfall #4 does have a long channel, compared to other outfalls, that has a relatively flat slope as it approaches the main flow area of the river. The channel could also use protection from erosion, since the channel walls have little vegetation to control the erosion. The current headwall is a U-shaped structure with the dimensions of 70" tall, 60" wide and 35" deep. The pipe inside the structure has a 12" diameter

A proposed alternative for Outfall #4 is to remove and replace the existing headwall. Currently, water exiting the pipe cannot flow freely from the outfall. The 12" pipe inside the headwall will need to be replaced. A section of guardrail from North Towerview Boulevard may need to be removed to access the damaged pipe. Soil will have to be excavated from the outfall to the location where there is a non-damaged section of existing pipe. A new headwall and pipe could then be installed. The replacement of the headwall is the only way to properly remediate the problems at this outfall. The pipe associated with this headwall is 12" in diameter. The cost of the new precast headwall needed for this size of pipe is \$495.00 as priced from Oldcastle Precast Headwalls. Figure 13 depicts the new headwall.

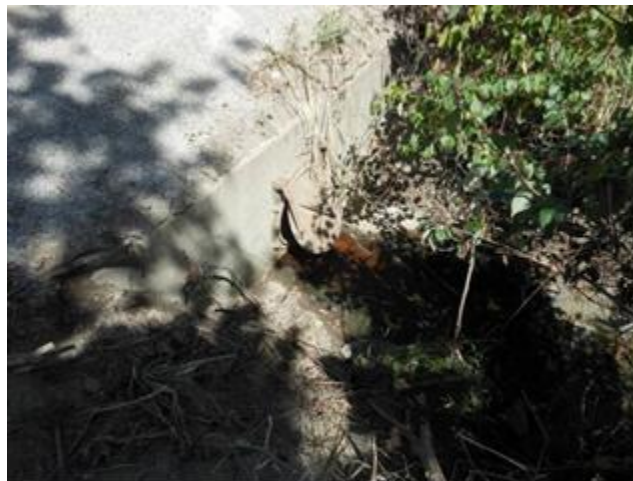
Figure 14 – Outfall #5

Outfall #5 is located in Reach 5. This outfall has a 21" pipe and a 37.5" tall headwall. The headwall and splash pad to the outfall are in good shape, but there are erosion issues due to poor bank stability in the channel. This head wall also contains a flap gate which prevents the river water to backflow into the pipe. Soil on each side of the headwall is loose and is eroding into the channel as shown in Figure 14. Outfall #5 has a relatively long flow channel that will also require erosion protection. Figure 15 shows the channel at Outfall #5. The eroding issues with this outfall are simple to correct.

The existing headwall at Outfall #5 is still in very good condition. There are no noticeable issues that would justify any repairs or the replacement for this headwall. The only concerns for this outfall reside in the channel erosion.

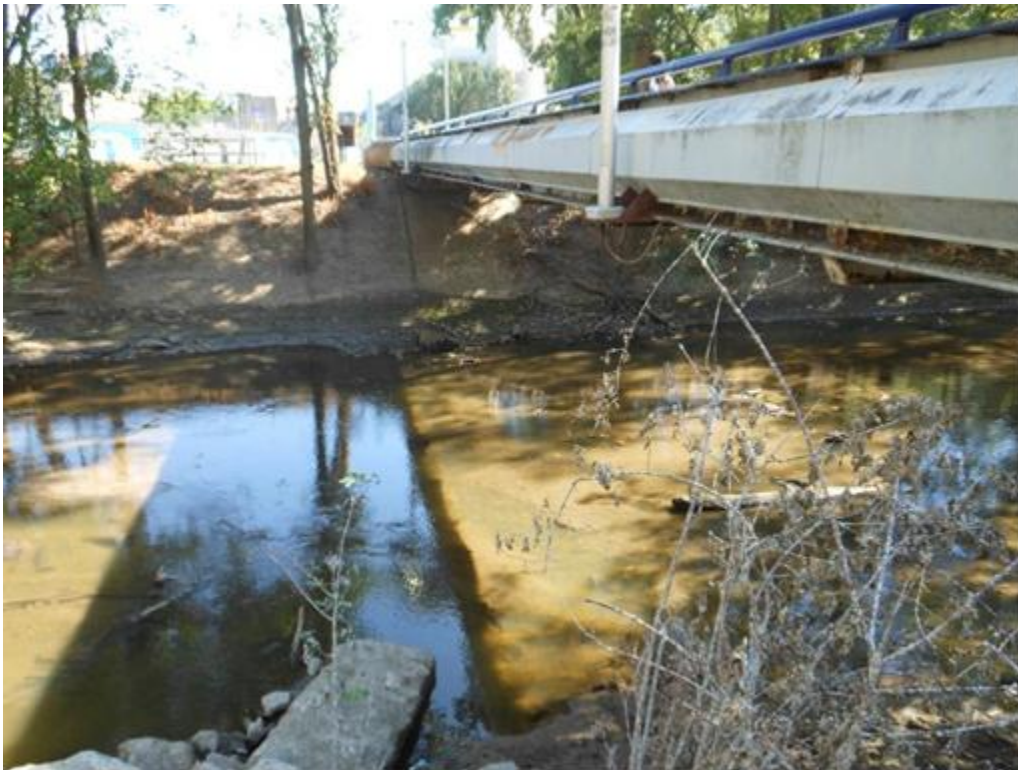
Figure 35-South Side of Carlson Bridge

Currently, the area beneath the Carlson Pedestrian Bridge appears to be undergoing significant erosion. An analysis of the area yielded the following concerns. As a result of the erosion there is limited bank stabilization. The North Slope is very steep, which amplifies the problem of erosion. On the bridge embankments, there is little to no vegetation growth to help stabilize the banks. This can be attributed to the steepness of the slopes and tough growing conditions under the bridge. As a result of erosion, small flow channels have formed on the embankments running into the river (Figure 35). The flow channels are carving away at the bridge slopes and washing away valuable soil that is needed to keep the structure in place. These small channels cause water to enter the river at an increased velocity. Because of this, the water entering the river is carrying the soil to the river. This also negatively impacts the water quality.

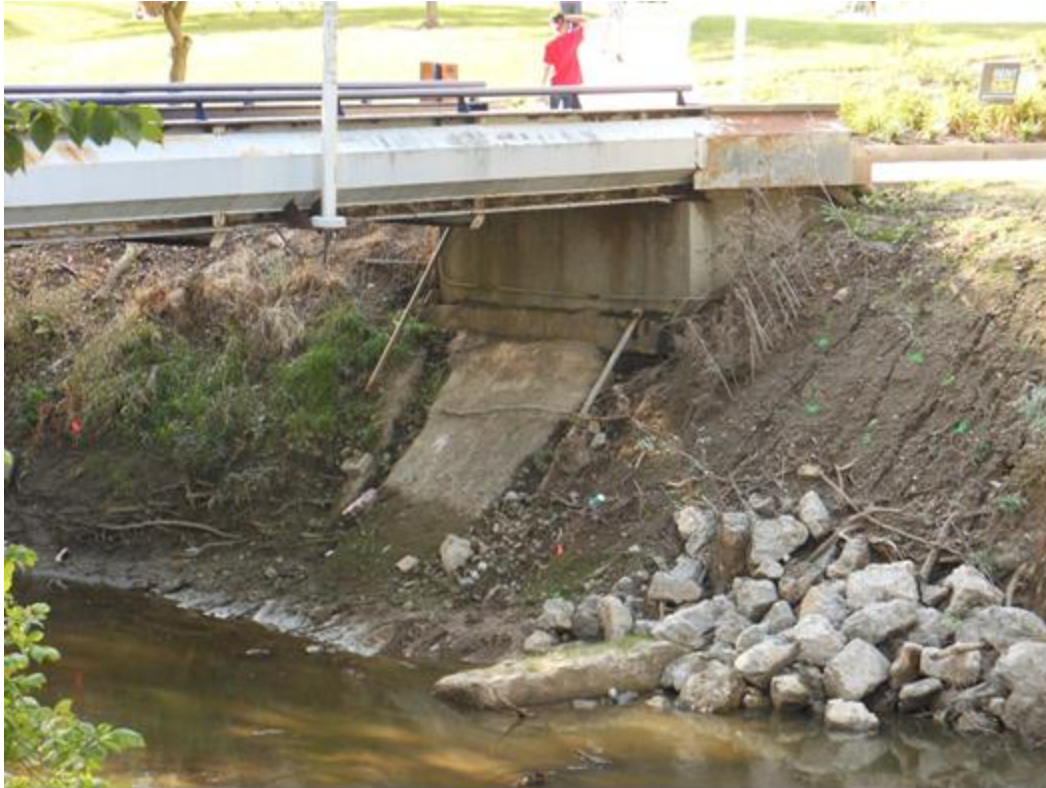
Figure 36-North Side of Carlson Bridge

The erosion under the Carlson pedestrian bridge is very significant. In the past and during previous construction, it appears that there has been a minimal effort made towards reducing the amount of erosion that takes place under the bridge. In addition, the erosion appears to have been occurring for a considerable amount of time since water has etched out a few significant pathways. The etching of these pathways is a process that takes years to accomplish. There are also many smaller, erosion formed flow channels in the soil that can be seen on both the North and South side of the bridge (Figure 36).

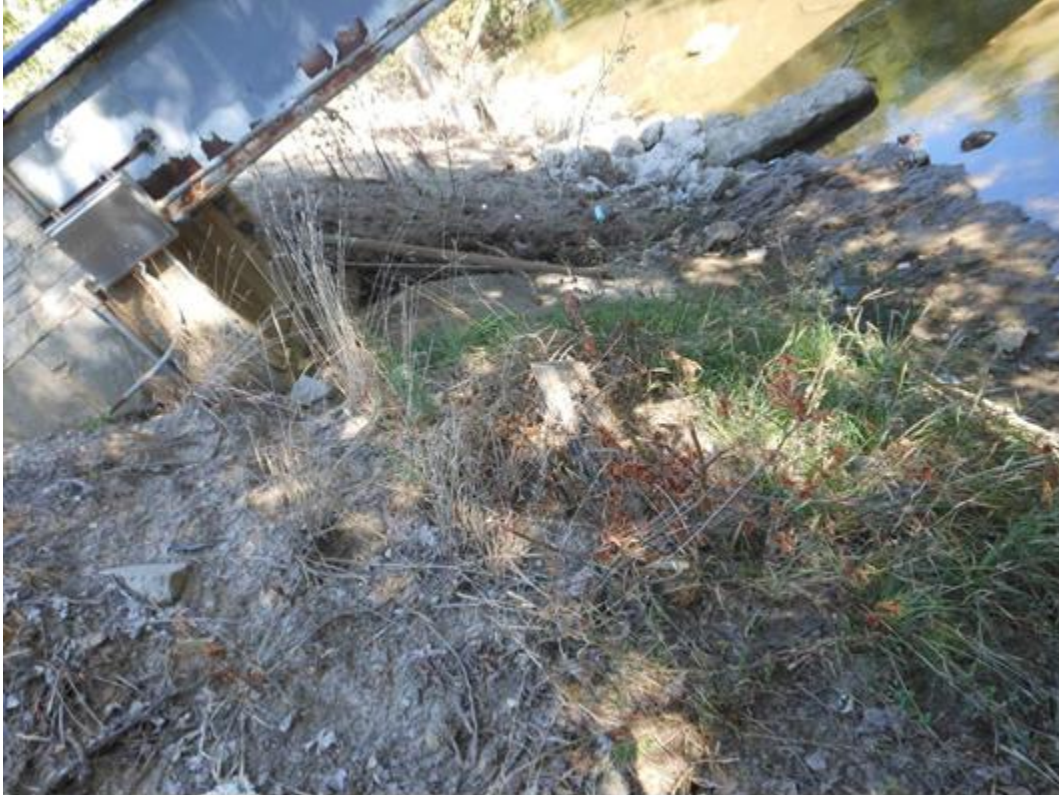
Figure 37-North Abutment of Carlson Bridge

Bank stabilization is the process of holding the soil of a bank in place so it does not wash away or slide. Bank stabilization is a very important aspect to any bank, especially on banks that serve as structural support. In the case of the Carlson pedestrian bridge, bank stabilization is very important. Due to the lack of stabilization under the bridge, much erosion has occurred over the years (Figure 37). The implementation of erosion control alternatives can be used to help stabilize steep bank slopes such as the North side of this bridge (Figure 36). Because the erosion that has occurred under the Carlson Pedestrian Bridge is determined to be repairable and preventable, it is a great candidate for a bank restoration.
