2013 Annual Report President's Commission on the River

River Restoration Project

Civil Engineering Senior Design Project: Storm water outfalls and bridges

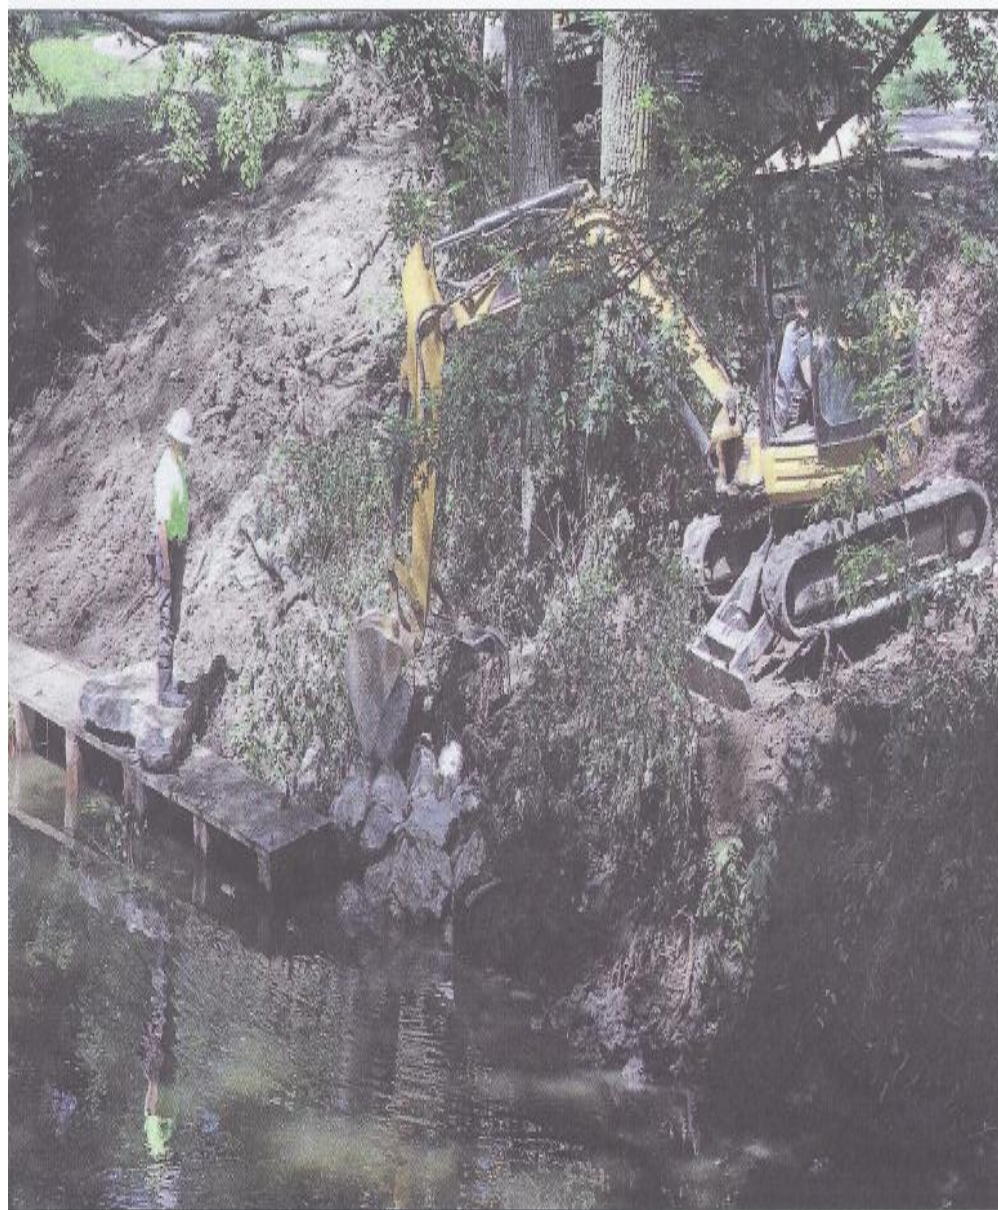
LET IT FLOW: Under the close supervision of Dave Derrick from the U.S. Army Corps of Engineers, Dave Hails of Ecological Restoration Inc. carefully placed cover stone for the fish habitat structures installed as part of the recently completed river restoration along the Ottawa River on Main Campus. "This phase focused on aquatic improvements, including adding large rocks and logs to mimic natural water flow and get a ripple effect in the water," said Dr. Patrick Lawrence, professor and chair of the Department of Geography and Planning, and chair of the President's Commission on the River. "Adding these natural materials will also make for more diversity to the aquatic habitat, giving fish and other aquatic organisms more places for nesting, spawning, food and shelter." The restoration work for the 2,700 feet of the waterway that runs through Main Campus was funded with a \$235,000 grant from the Ohio Environmental Protection Agency and a \$151,000 grant from the U.S. Fish and Wildlife Service. The project also involved the assistance of Toledo Metropolitan Area Council of Governments, EnviroScience and Partners for Clean Streams.

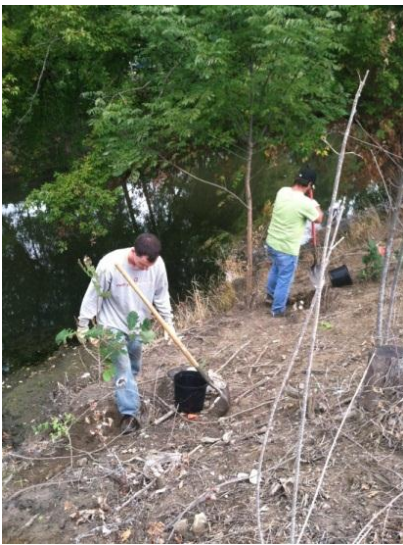
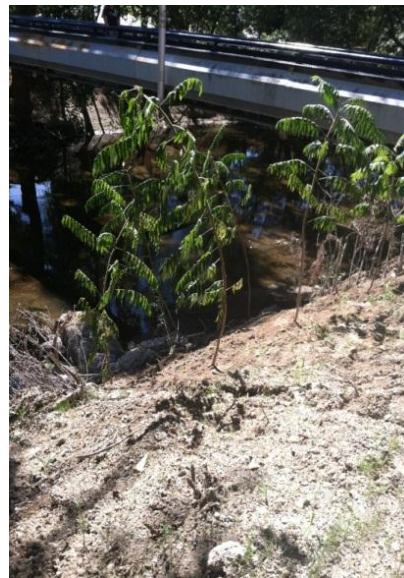
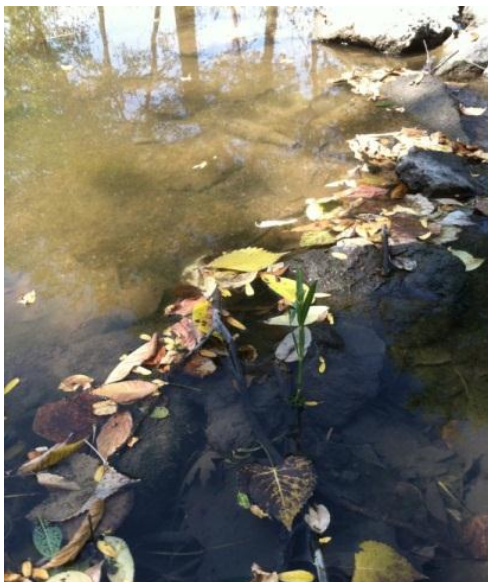
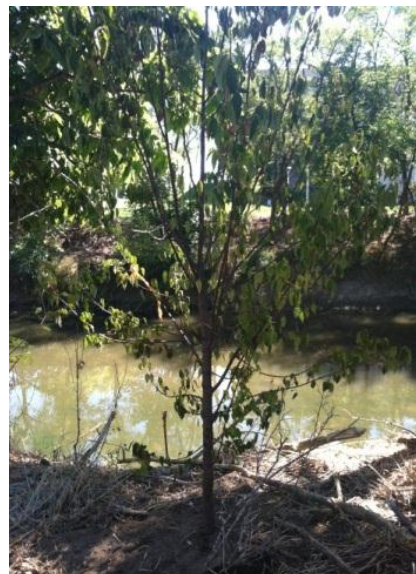
Replanting (September-October 2013)

- 400 water willows in river bed
- 325 native plants along the bank, 25 species including Burt Oak, Dogwood, Indigo Bush, Black Chokeberry, Hazelnut, Black Walnut, Tulip Poplar, Hornbeam, Ninebark, Sycamore, Black Cherry, Sumac

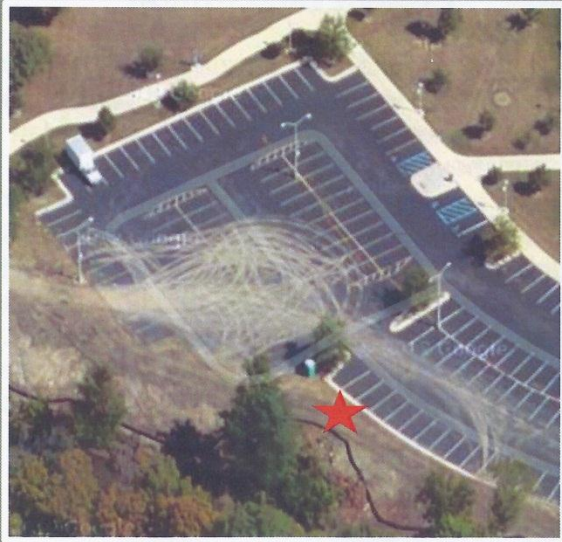
Tree Filter Location

The proposed tree filter will be located in the southwest corner of parking lot 12W of the UT law center. The existing 18" stormwater outfall is buried under construction debris and decaying vegetation.

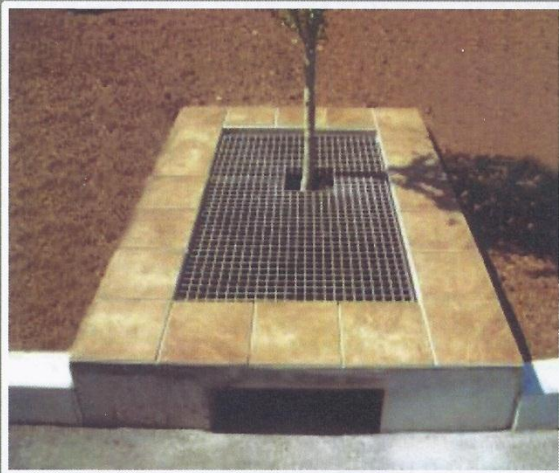
Example Retrofit

The proposed tree filter will be integrated with the existing curb and stormwater infrastructure. The system will slow discharge velocities to the river, provide preliminary treatment and relieve peak flow events.

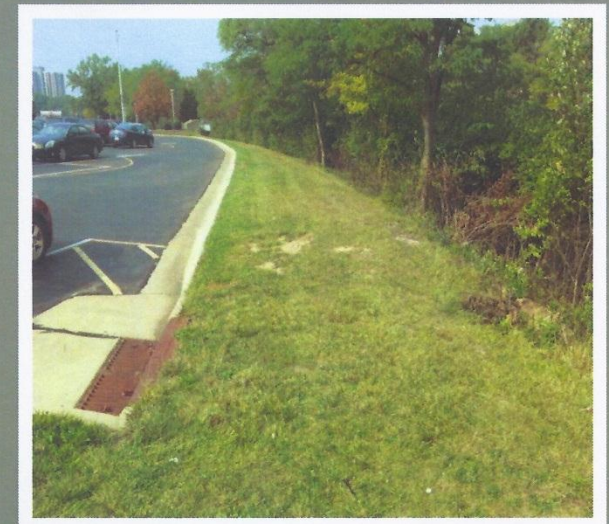
Existing Site Conditions

Bioretention Basin Location

The proposed bioretention basin will be located in the grassy area along the north edge of Parking Area 3, near Savage Arena. An existing portion of the gutter pan will be removed to create additional space. The proposed location is denoted by the blue rectangle in the picture above.

The proposed bioretention basin is an 85' vegetated rectangular channel that conveys stormwater to the existing inlet catch basin in the northeast corner of Parking Area 3. The depth of the bioretention basin is 3', which provides sufficient retention time for infiltration, biological conversion and vegetative uptake to occur.

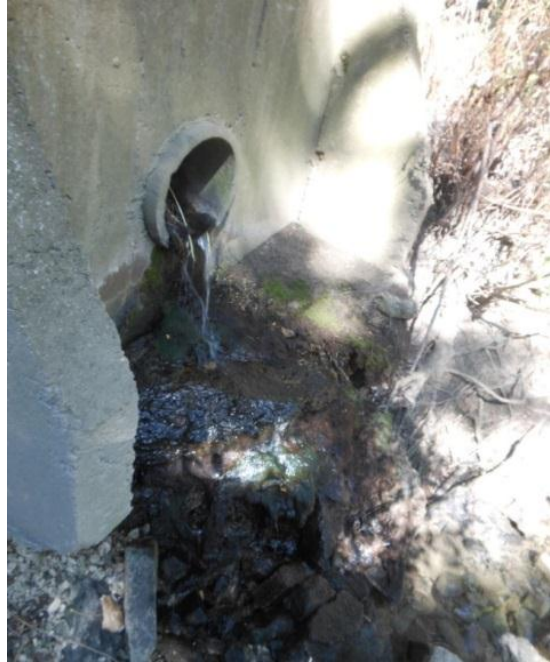
Repair Headwall at Outfall #1

- Remove broken splash pad
- Remove loose soil and obstructions around headwall

- Shore headwall with compacted rip-rap
- Pour new concrete splash pad
(82" wide, 24" deep, and 6" thick)

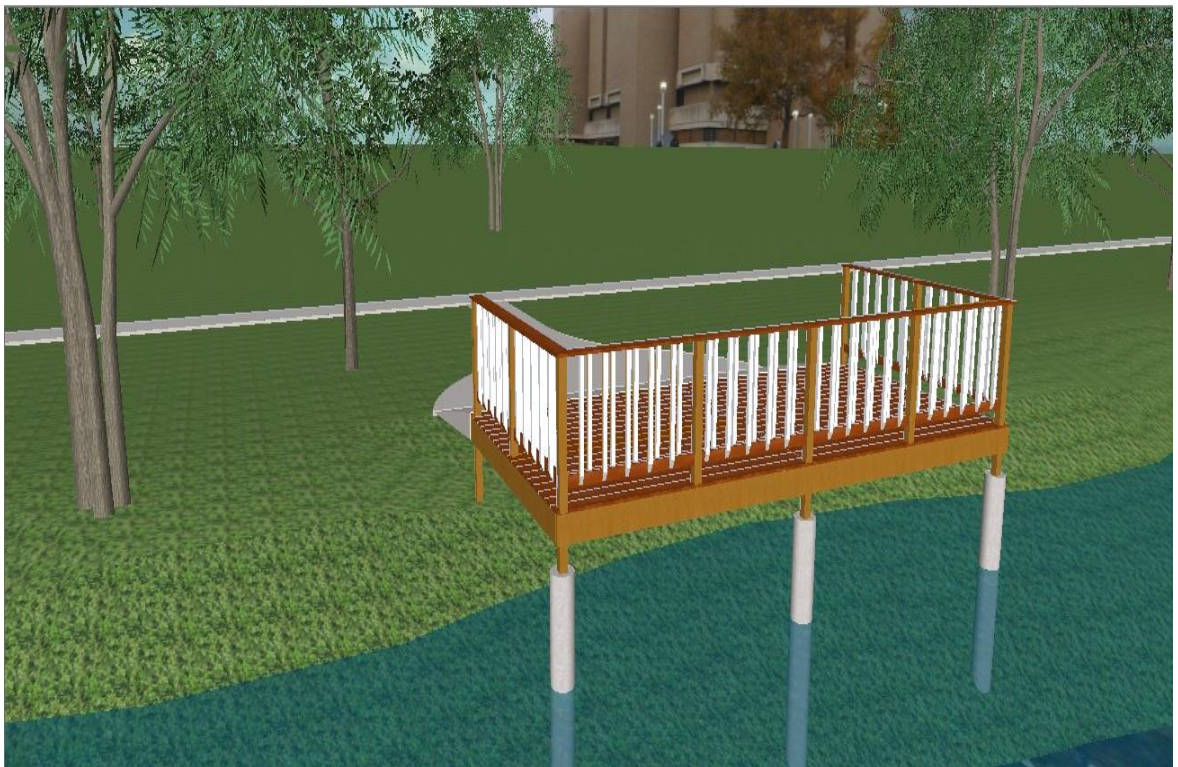
Overlook Addition At Outfall #1

- Provide place for fishing or enjoying view
- 12' x 18' Composite wood/treated wood platform
- 25 psf dead load, 20 psf snow load, and 100 psf for people capacity
- Factored design ultimate load of 222 psf
- Railing will provide fall protection
- Ramp will allow easy access
- Estimated materials and labor is \$10,000 to \$12,000

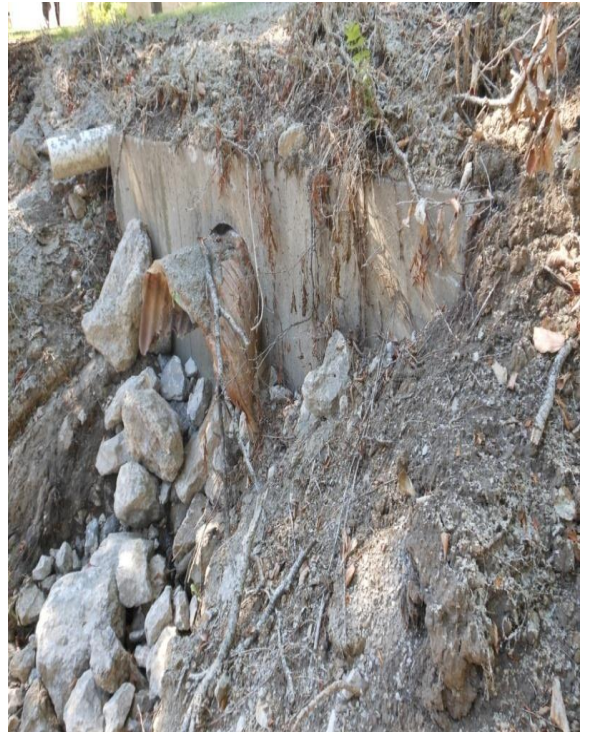
Outfall #2

- Damage to corrugated pipe
- Outfall channel erosion issues
- Large elevation difference from outfall to water level

- Cut pipe flush to headwall
- No modifications to headwall

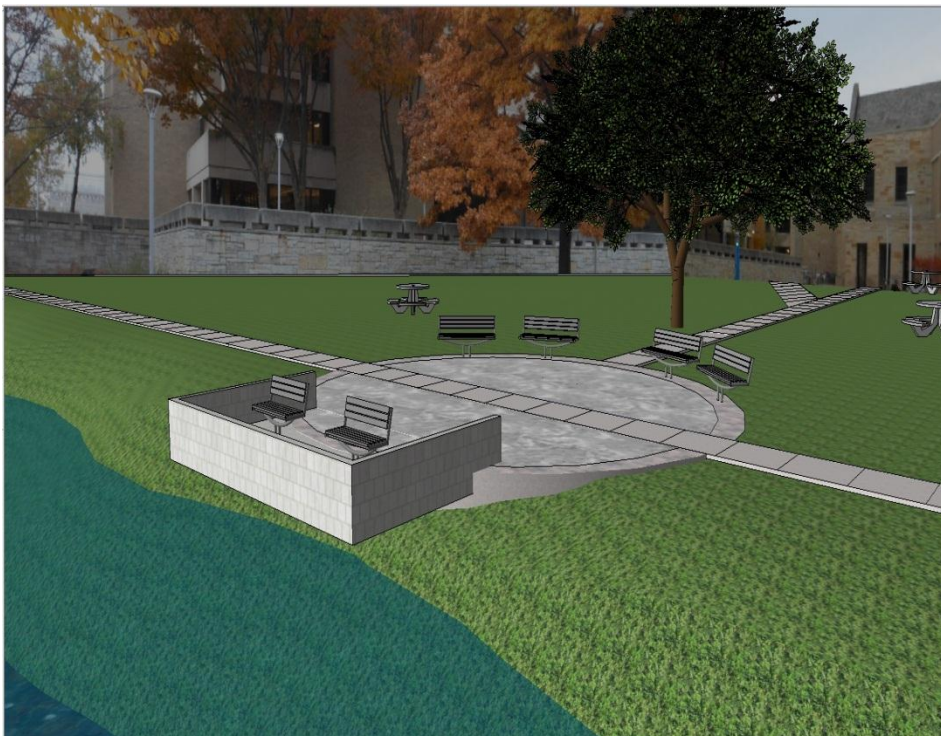
Overlook Addition At Outfall #2

- Ties into Student Garden Plaza
- Concrete Cantilever based design
- A 12' x 20' area will be required for this addition
- 150 psf dead load, 20 psf snow load, and 100 psf for people capacity
- Factored design ultimate load of 372 psf
- Railing for safety
- Bench seating

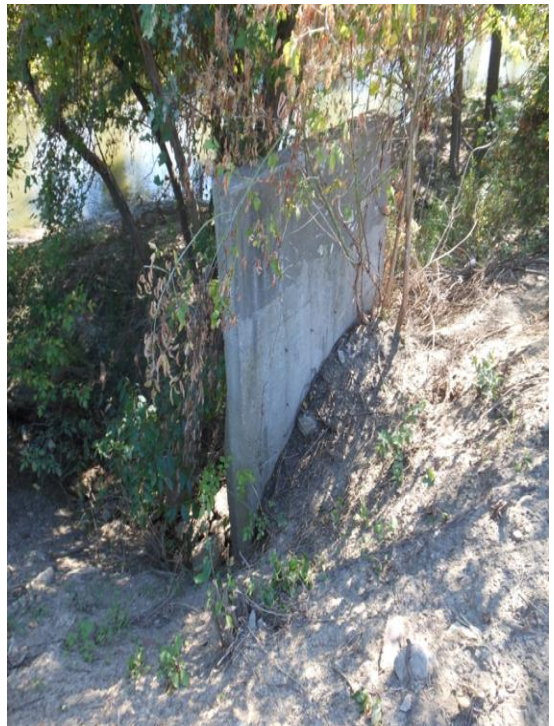
Repair Headwall at Outfall #3

- Pipe has broken off inside the Headwall
- Soil erosion issues
- Outfall channel protection

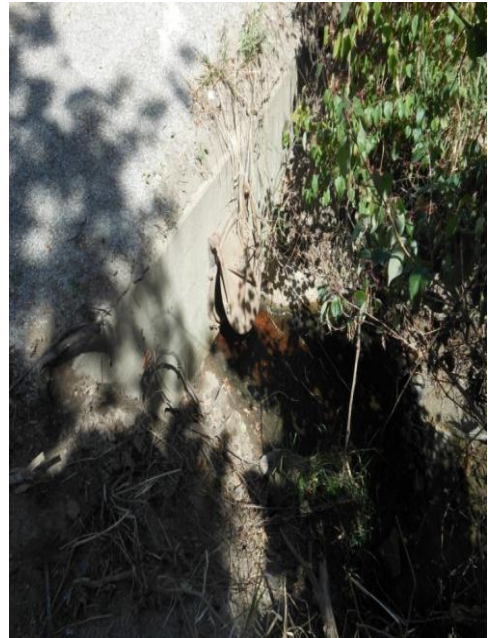
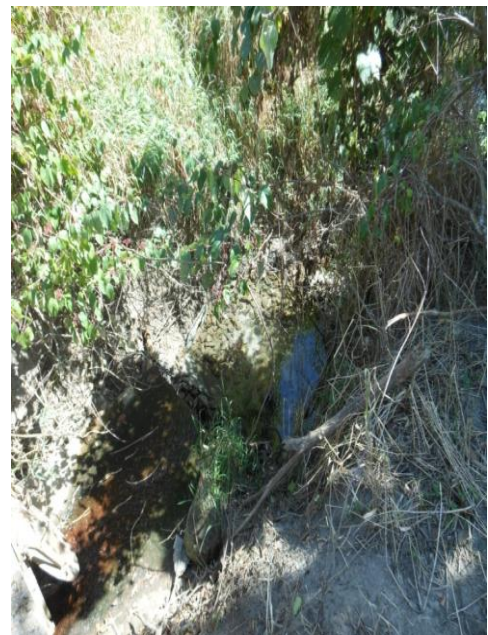
Outfall #5

- Headwall and splash pad are in good condition
- Erosion issues
- Outfall channel protection needed

- No alternatives due to good condition of structure, pipe, and splash pad

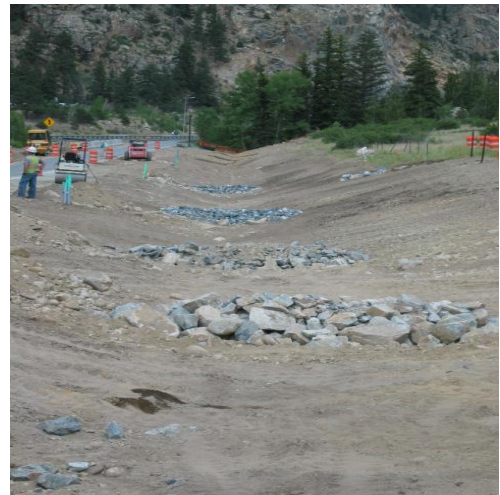
Rip Rap

- Using outlet velocity
 - Outfall 3 velocity = 9.316 fps
 - Outfall 4 velocity = 6.405 fps
- Type C rip rap
- Cross sectional area for volume

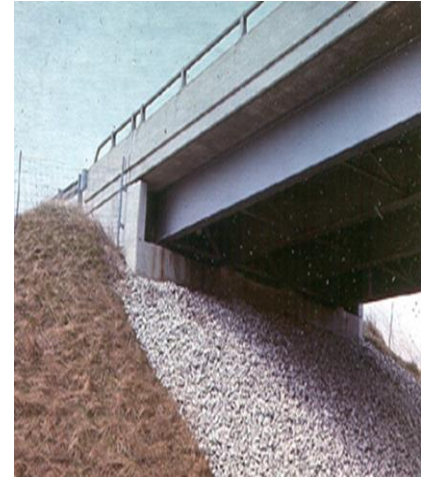
Application of Rip Rap

- Commonly used and cost effective
- Rocks size based on river conditions
- Easy to install and maintain
- Aesthetically pleasing to most

- Rip rap sizing based on river flow velocity (HEC-RAS)
- Type C rip rap
- Volume of rip rap was determined by using the area under the bridges placed one foot thick

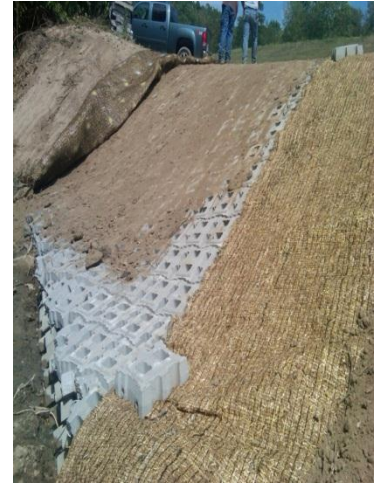
Articulating Concrete Block with Holes

- Same design process as outfall alternatives
- Based on river parameters and block design
- Factor of safety target is 1.4
- Select block to meet factor of safety (SD-400 OC block from SHORETEC)
- Open-celled blocks were chosen to promote plant growth

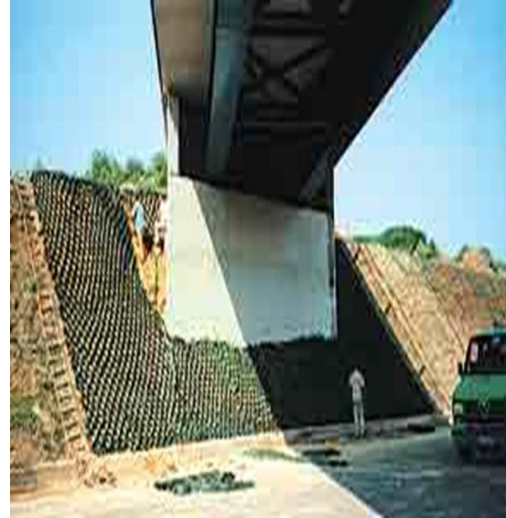
Installation of Geo-Mat

- Based on bank slope and fill material properties
- EGA 30 geo-mat was selected from Geo Products, LLC
- Mat must be anchored to the river bank
- Area under each bridge determine mat area
- #57 Stone used to fill the cells within the mat
