Evaluation of Fan-Pattern Spray Nozzle Wear Using Scanning Electron Microscopy

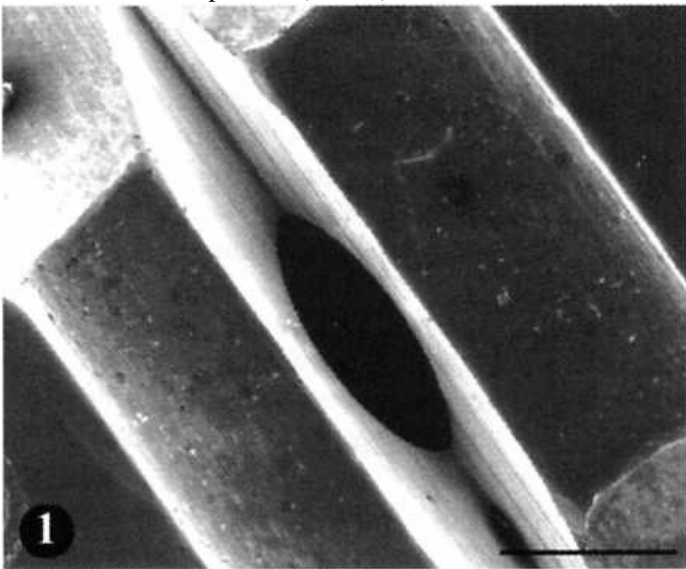
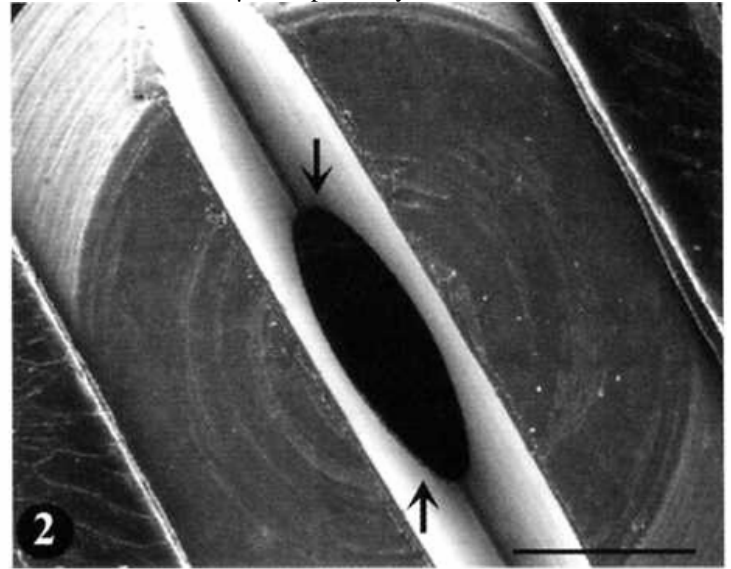
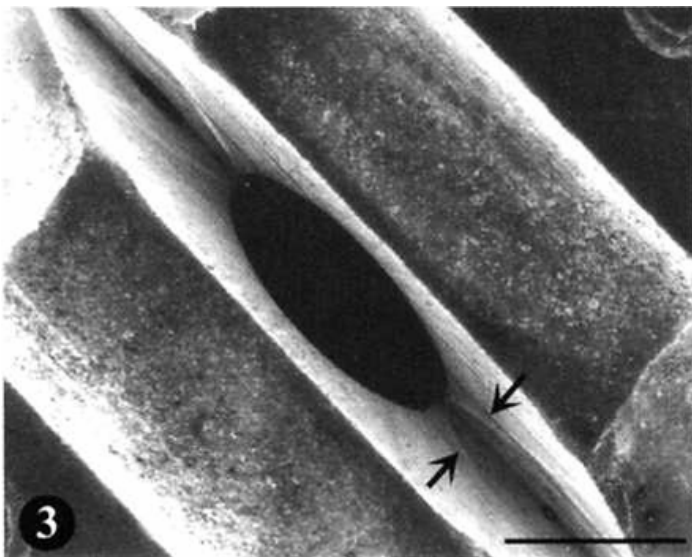
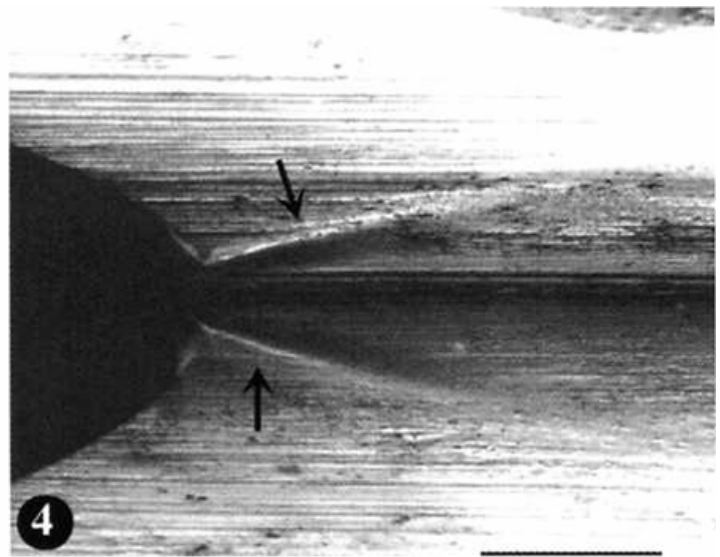
Figure 1.(1) Scanning electron micrograph of an unused brass nozzle. Bar = 700 μm . (2) Scanning electron micrograph of an unused stainless steel nozzle. Note the rough edges at the arrows. Bar = 700 μm . (3) & (4) Scanning electron micrograph of worn brass nozzle. Note wear patterns (arrows) and increased width of orifice. Bars = 700 and 300 μm respectively.

Scanning electron microscopy (SEM) was used to observe worn and unused brass and stainless steel flat-pattern spray nozzles. Wear and other changes were observed in both nozzle materials. Scanning electron microscopy can provide nozzle manufacturers with greater insight and needed information on nozzle mechanics. More reliable delivery of pesticide spray should enhance integrated pest and disease management and crop protection for growers.
