Habitat Restoration of the Ottawa River at the University of Toledo, Ohio

by Dr. Patrick Lawrence

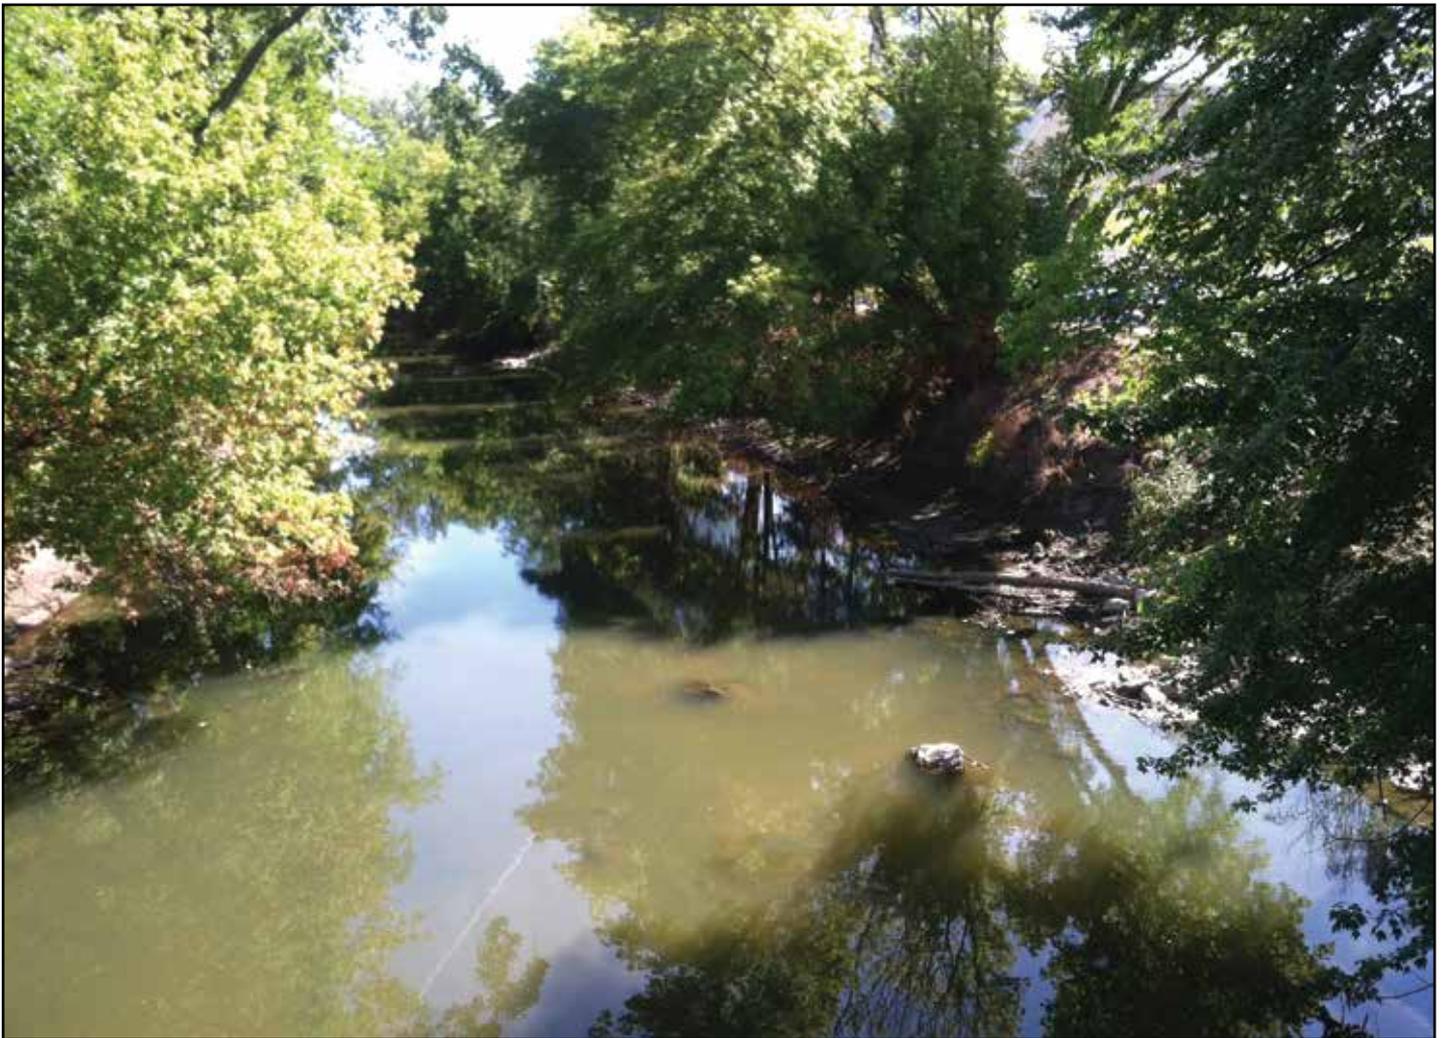
Reach 5 post construction view of hydraulic cover stones and bendway wier with locked log.

A Bendway Weir (BW) is a stone structure that extend from the bank and angle upstream 70 degrees from a line tangent to the bank. As opposed to Rock Vanes/Bank

Barbs, they are level crested (flat) along the longitudinal axis. The length depends on the amount of river that needs to be controlled and proposed thalweg relocation. The height of a BW is usually one foot above the base flow water surface elevation (typical lowflow or 80 percent exceedence). The crest of the weir needs to be lower than any flow that can erode the bank. Water flowing over it is redirected at an angle that is perpendicular to the longitudinal axis of the weir. Because it is angled upstream, this pushes the erosive energy (flow) away from the outer bank of the stream. The erosive helical flow, that is created as the stream travels along the bend, is broken up and the stream velocity over the weirs drops by approximately 50 percent. This reduced flow velocity creates a resting area (within-channel refugia) and increased structural diversity for fish. One study shows that adding weirs increased species richness of fishes by 260 percent and individual numbers by over 24,000 percent. Because of the slower stream velocities along the outer bank, weirs will allow for deposition and plant colonization to occur along the outer bank of the bend of the river and sometimes in the area of the weirs. Also the deepest section of the river (thalweg) is moved from the outside of the bend of the

A Hydraulic Cover Stone (HCS) is a large single stone placed singly, or in grouping, in a flowing channel. The constant movement and undulation (rippling) of the water from the HCS results in a type of cover, hydraulic cover, that masks fish location from the view of predators. The stones also provide resting areas and in-channel refugia for fish during high-energy, highflow events. Three stone placements create three different hydrologic scenarios:

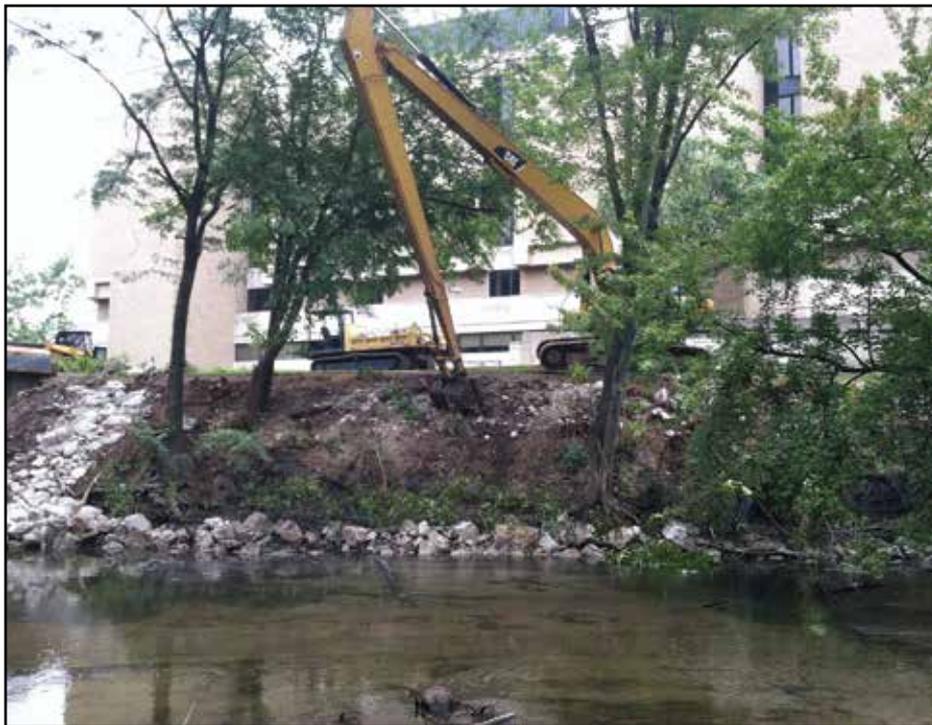
Construction of longitudinal toe protection structure.

A Longitudinal Peaked Stone Toe Protection (LPSTP) is a continuous stone dike placed longitudinally at or slightly streamward of the toe of the eroding bank. It is triangular in cross-section. The LPSTP does not necessarily follow the toe exactly, but can be placed to form a smoothed alignment through the bend. However, in some cases a smoothed alignment might

not be desirable from the environmental or energy dissipation points of view. The amounts of stone used (i.e., 1 ton/lineal foot, 2 tons/lineal foot) will depend on the depth of scour at the toe, estimated stream forces (impinging flow) on the bank and flood durations and stages. A benefit of this type of protection is its ability to resist the erosive flow of the stream and stabilize the toe of the slope. It does not directly protect mid and upper bank areas. The success of the method depends on the ability of the stone to launch into a scour hole and self-adjust, protecting the bank against further erosion. Bank grading is not always needed; therefore any established vegetation above the crest of the LPSTP may not need to be disturbed. Typically adventitious rooting live poles are placed against the stone on the bank side, then the area between the stone and the native bank material is backfilled (which plants the live poles) and creates a floodplain bench. The LPSTP and poles (live siltation) will capture alluvium and any failed upslope material on the bank side creating an area for vegetation establishment.

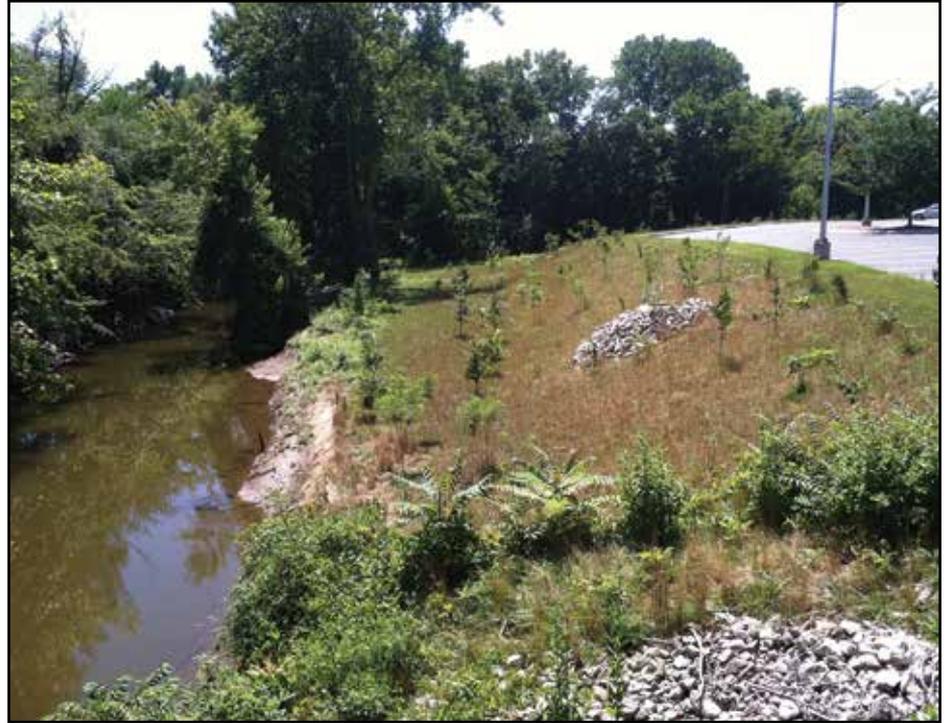
Cutbank feature in Reach 1 in the summer of 2013, one year post construction.

With the construction of the cutbank complete, planning for the in-stream habitat restoration proceeded in the fall of 2012 with final design and public meetings. The final design called for the installation of twelve in-stream restoration structures and sixty hydraulic cover stones along 2,800 linear feet of river. The structures included: six locked logs; two sets of LUNKERS (total length 88ft); one section of Longitudinal Peaked Toe Protection (200 linear feet) with five single stone bendway weirs with a stone smile structure, and three bendway weirs with locked logs. Stone would come from local quarries and the locked logs built from hardwood trees donated from a local landowner and from site. The in-stream structures would be anchored into the bank, protected with rock stone keys at each end that extended several feet deep and up to fifteen feet with the bank and where filled with stone, choked with soil and planted with live stakes of willows and other locally harvested plants. The number, location and select of the various types of in-stream restoration structures was determined based on current habitat conditions, addressing flow conditions and to provide a range of different habitat structures so as to be able to assess their relative functions and long term successes to improve aquatic habitat conditions. Final concept plans and design were completed by the USACOE and provided to the project team in December 2013 along with detailed cost estimates by river reach and structure type.

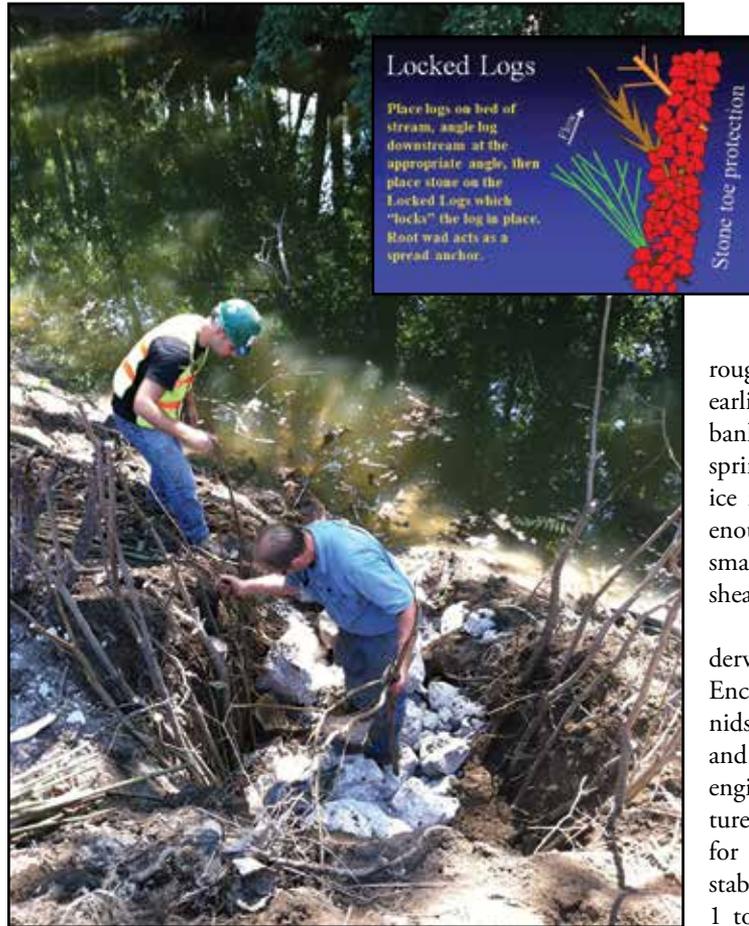
Installation of live stakes in locked log feature.

Locked Logs (LL) consist of entire trees, generally larger than two inches in diameter anchored in or placed under structures. Locked limbs are smaller branches (with or without leaves), tree tops or sections of small tree trunks that are less than two inches in diameter. They can be placed into a stream by hand or with mechanical assistance. Depending on size of the

woody material and the stream, they can be placed singularly or in bundles of several logs. These structures are secured into the bank or locked by placing stone around the lower portion of the tree with the upper portion pointed downstream at typically a 15 to 35 degree angle relative to the bank. Trees that still have attached root wads are preferred because the roots act as a spread anchor in the stone and don't allow them to work out from underneath the stone. Care should be taken to make sure to anchor the tree or limb to the bank so that the woody debris does not break free and create more work downstream. Avoid the use of mechanical fasteners such as cables. If the structure fails, cables can cause problems downstream where they can become lodged. They provide in-stream cover, vertical and horizontal structure, hydraulic roughness and faunal refugia. Dead wood in a stream is extremely important for macroinvertebrates, both as food supply at the base of a food web and as a substrate/habitat. These logs provide cover and feeding

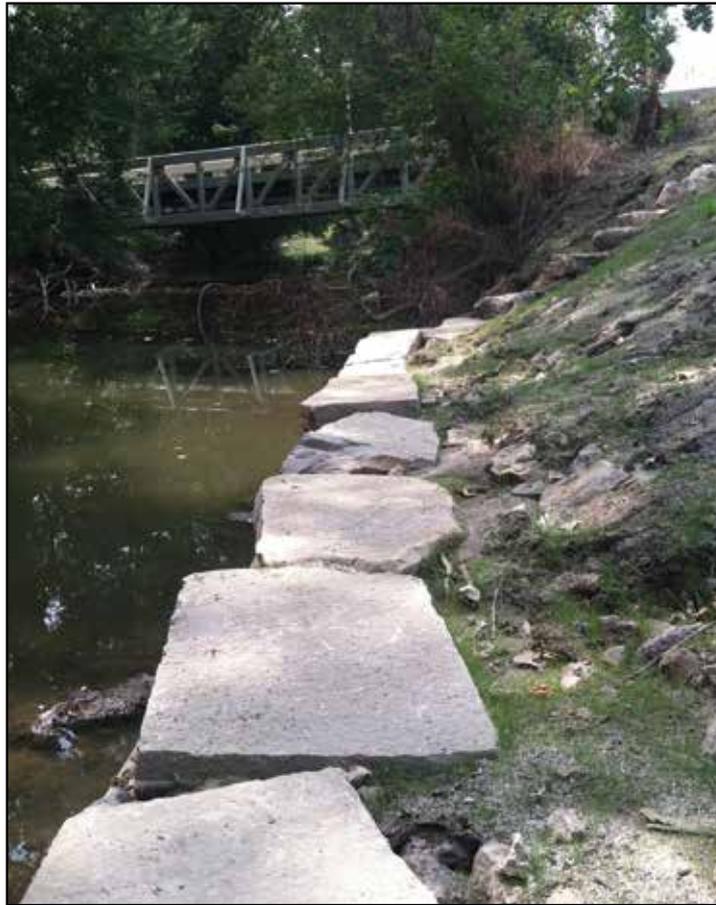
Above: LUNKERS, post construction. Below: Placement of eight foot section of LUNKER in Reach 3.

A LUNKERS (Little Underwater Neighborhood Keeper Encompassing Rheotactic Salmonids) structure was first developed and used in Wisconsin. It is an engineered, undercut-bank structure designed to provide habitat for fishes while providing bank stability. It is typically 8 feet long, 1 to 2 feet tall and 3 feet deep, constructed of hardwood or if numerous wet-dry cycles are anticipated, concrete or plastic-wood. It is open to the front and sides of the structure to allow for water to flow through. The toe of the outer bank of the stream is leveled. The structure is placed on the level bed and 0.5 inch x 7 foot long sections of rebar are driven through pre-drilled holes and into the stream substrate, anchoring the LUNKERS to the stream bed. The area bankward of the structure is filled with riprap or covered with large stones and some soil. Circular coir fiber rolls are positioned on top of it to provide substrate for vegetation. Concrete-roofed LUNKERS can be used as fishing platforms in handicapped accessible facilities. It is important that it is placed on the outside of the bend of the stream that will receive flow. Otherwise, sediment fills up in it, deeming them functionally useless.
