Veterans' Glass City Skyway Bridge Main Cable Evaluation

Prepared by:
Serhan Guner

Prepared for:
The Ohio Department of Transportation,
Office of Statewide Planning & Research

Final Report

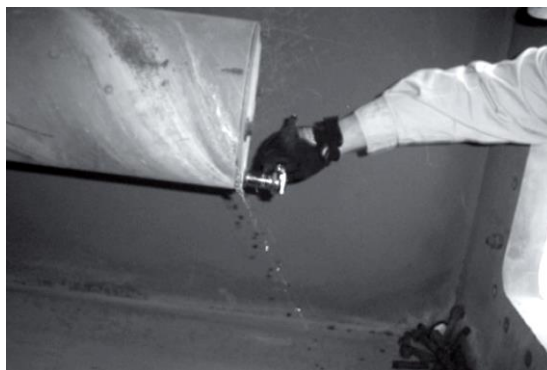
The relevant literature, case studies, and subject matter expert interviews conducted for this study indicate that the deterioration of strands typically starts *at the anchorage zones* as opposed to the free lengths of the strands (Figure 4 [1,7]). Factors contributing to this phenomenon at the anchorage zones include high-stress concentrations, high potential for water ponding, exposure to de-icing chemicals and other contaminants, large transverse forces in the saddles especially at the entrances to the pylon, and the deterioration of water infiltration prevention measures over time (e.g., washers, rings, filler grease, etc.).

(a) Significant corrosion found in an anchorage

(b) Water exiting the end cap of the anchorage

Figure 4 Sample corrosion cases at the anchorage zones.

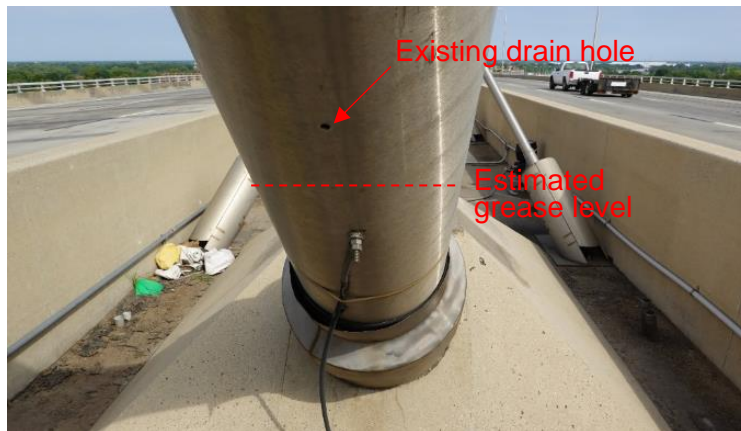
Visual testing methods are extensively used for the inspection of hard-to-reach areas. The studies indicate the suitability of a borescope inspection of the lower ends of the stays above the grease line. The available drain holes can serve as the required access ports (Figure 5). This requires selecting a suitable borescope with a probe small enough to fit the existing holes. The lower ends of the stays are a high-risk location for corrosion and other types of deterioration conditions. Therefore, such an inspection can give valuable information about the condition of the lower ends of stay cables. A borescope inspection can also help assess the condition of the grease (e.g., viscosity, level, and presence of ridges). This method provides capabilities for taking photos and videos as needed during the inspection. Due to the visual nature of the method, its accuracy and reliability are high.

Figure 5 Lower ends of stays with a drain hole.

During the inspections, it was noted that not every B stay has a drain hole, while all A stays have drain holes. The stays without drain holes are 9B, 10B, 14B, 16B, 17B, 18B, 19B, 20B. It is recommended to add drain holes to these stays, matching the diameter and location of the existing ones.

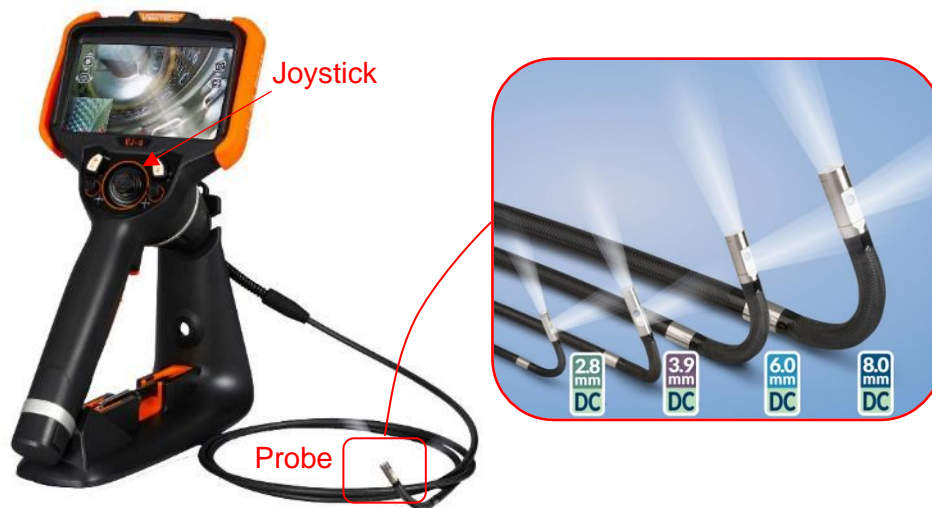
For the VGCS, the research found the dual camera borescopes to be the most suited among various options (Figure 6). These units have a side-view camera in addition to the traditional front-view camera. This can allow better inspection of the strands when the probe is inserted parallel to the strands. A four-way articulation capability is also needed. This uses a manual or electronic mechanism via a user-controlled joystick to move the probe in all four directions. This allows more precise movement of the probe towards the areas of concern during an inspection. Almost all current borescopes are powered by rechargeable batteries with an average service life of three hours. Consequently, multiple battery packs are required for an inspection which may take the entire day.

Figure 6 Sample borescope with a dual-view camera.

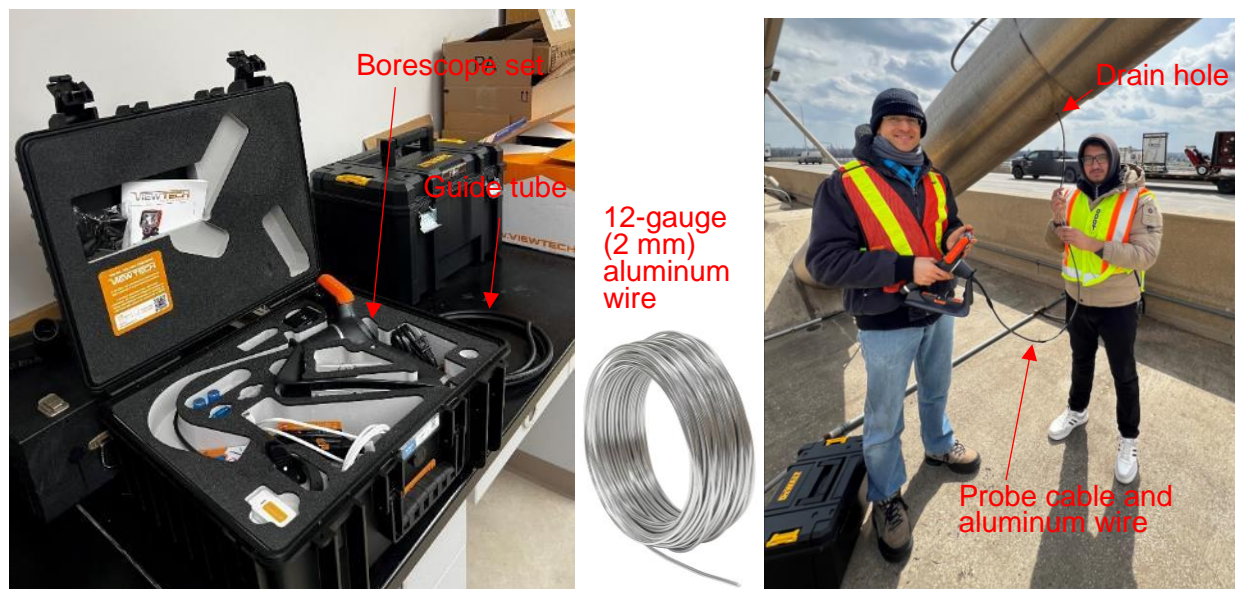
The borescope inspection and grease sampling were completed on April 9, 2024. A dual camera VJ-4 video borescope, with a 6-mm diameter probe and 5-ft cable length, was used. The guide tube provided was too large to fit the drain hole. A semi-rigid aluminum wire was used instead after running it along the probe cable connected with electrical tape at approximately every foot. A segment of this wire was also used for the collection of grease samples. The items used in the inspection are presented in Figure 7.

Figure 7 Boreoscope setup used for the inspection.

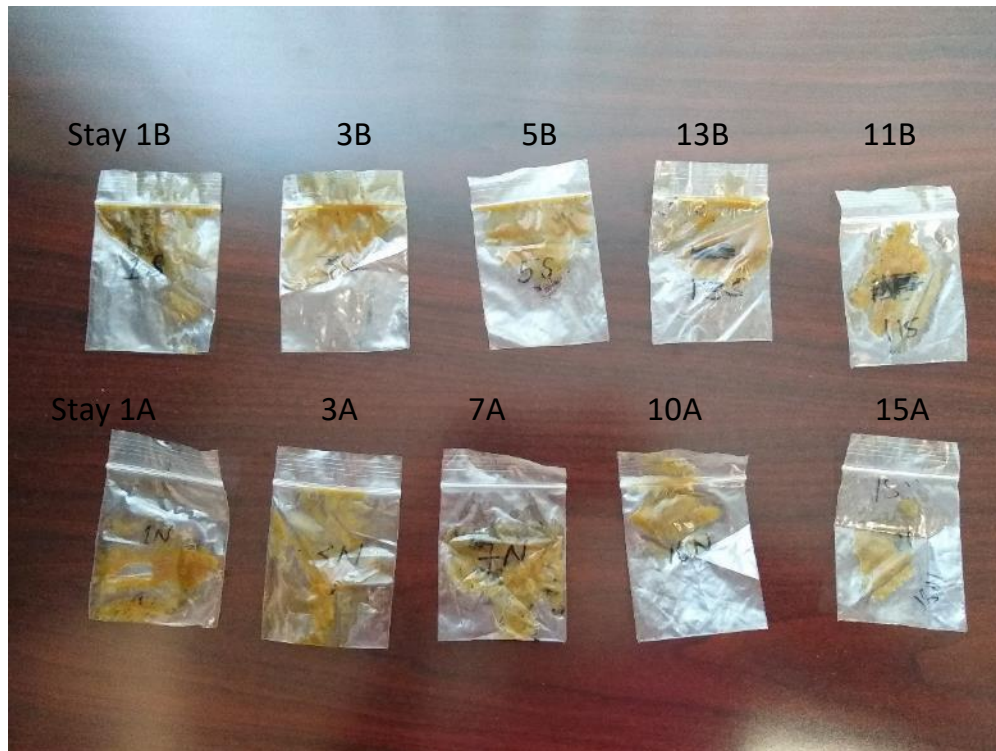
In addition, grease samples were collected from ten stays and are presented in Figure 9.

Figure 9 Grease samples collected from the lower anchorage zones.

The inspected strands appeared to be in very good condition with no signs of epoxy coating damage, chipping, or corrosion. The dusty state of the strands implies no water runoff and dry conditions. The grease at the lower end of the stays appeared in good condition with no sign or presence of water. The collected grease samples appeared in very good condition with consistent color, viscosity, and consistency.

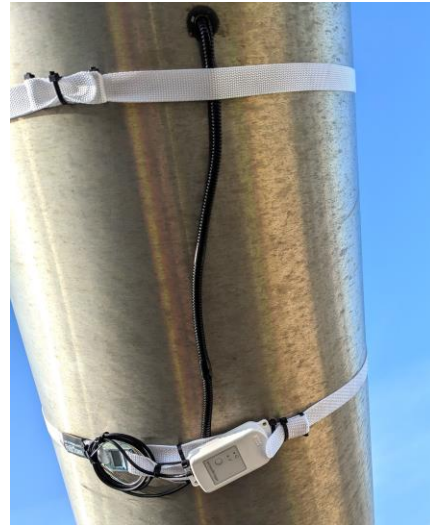
The existing drain holes were used for the insertion of the probes of the internal loggers. It was important to insert the probes upwards to prevent rainwater running along the cables and sensors from falling into the grease beneath. This was not possible with the thin and flexible probe cables. To increase their rigidity, 12-gauge aluminum wires were attached along the probe cables using electrical type, as was done in the borescope inspection. In addition, the combined probe cable and aluminum wire were placed in plastic wire loom auto-split tubing. This was necessary for preventing potential damage to the probe cable due to constant wind and traffic vibrations, especially at the drain hole where the cable goes inside the stay. High-quality straps were used to support the loggers and cable bundles outside the stays. Ample amounts of zip ties were used in the installation. The hardware used in the installation is presented in Figure 12. A sample installation and installed logger are shown in Figure 13.

(a) Stay 2B

(b) Stay 15A

Figure 13 Internal logger installation on site.

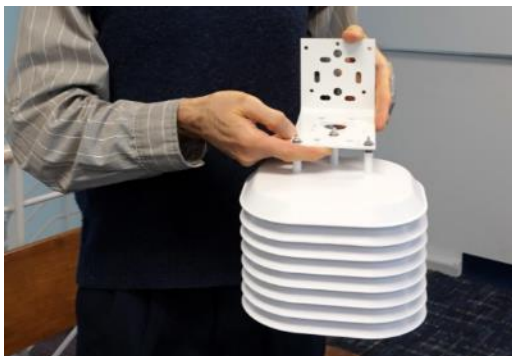
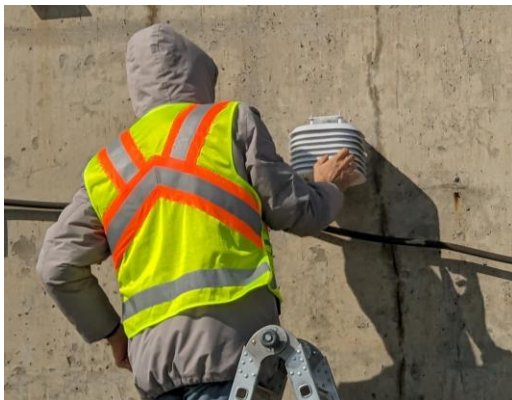
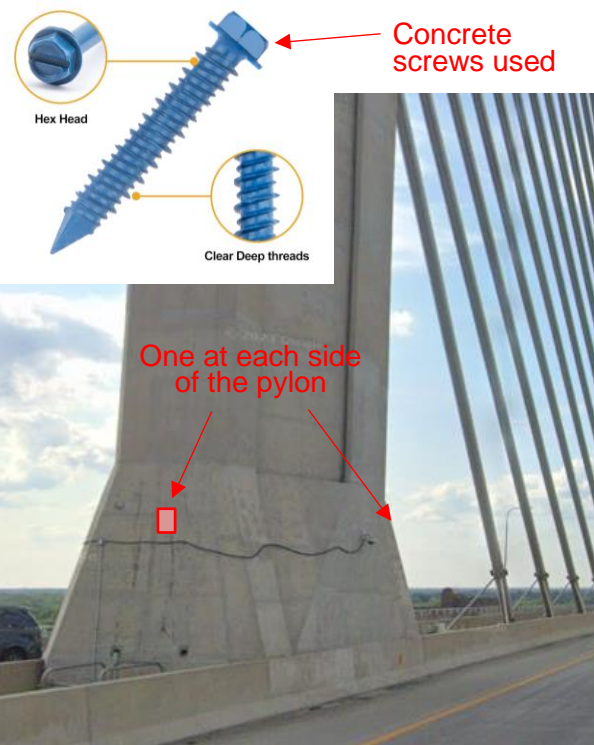
The external loggers were installed inside the solar radiation shields manufactured for the specific logger model used. The purpose of this shield is to block direct sun exposure and create a consistent measurement environment for both external loggers. One external logger/radiation shield bundle was installed at each side of the pylon using concrete screws (Figure 14).

(a) External logger-radiation shield bundle

(b) Installation on the pylon (EXT-B)

(c) External logger-radiation shield bundle installation locations (B side is shown)

Figure 14 External logger installation on site.

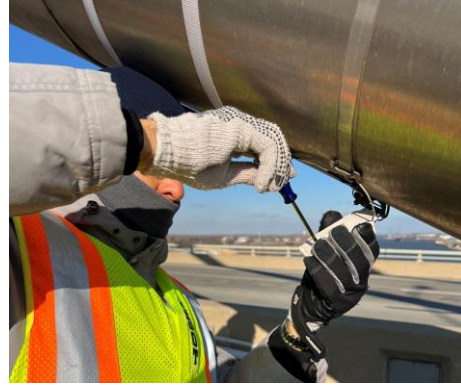
The loggers were installed on February 28, 2024. The first data download took place on April 9. All loggers were working as intended on this date. During the subsequent data download on November 7, 2024 (Figure 15), it was noted that the logging interval was reset to one minute after the data download on April 9. This caused the memory to be full on May 1, and no further recording could be made after this date. This arbitrary change in the configuration after data download may be noted as one weakness, or a bug, of the software controlling the loggers. The software did not give any warning or notification for this configuration change.

During the data download on November 7, Logger 15B was found non-operational due to battery drain. The logger was removed and taken back to the lab. The data was still available (until May 1) once the battery was replaced. This raised a concern about imminent battery drain with the remaining loggers; therefore, a battery-replacement site visit was scheduled for November 26. It should be noted that the manufacturer's specified battery life expectancy is five years, whereas the batteries lasted about nine months. The date of manufacture is stated as November 2022 on the batteries. This indicates a two-year battery life, including the time that non-recording loggers were waiting on the shelf.

(a) Data downloading on Nov 7, 2024.

(b) Battery replacement requires the opening the back cover held by four screws.

Figure 15 Logger data downloading and battery replacement.

A subsequent site visit was made on November 26 to replace the batteries of all loggers. Six internal logger batteries were replaced. Replacing the two external logger batteries requires the use of a ladder and disassembling the radiation shields. This was not done due to cold and windy conditions. The data from November 7 to 26 was also downloaded during this visit. The data showed that the humidity sensor of Logger 8B had malfunctioned, with no humidity data recorded. The batteries of the external sensors were replaced on January 30, 2025. During this visit, the data from all loggers were also downloaded. The data showed that Logger 8B had stopped working on January 18, 2025, with no temperature or humidity data recorded afterwards.

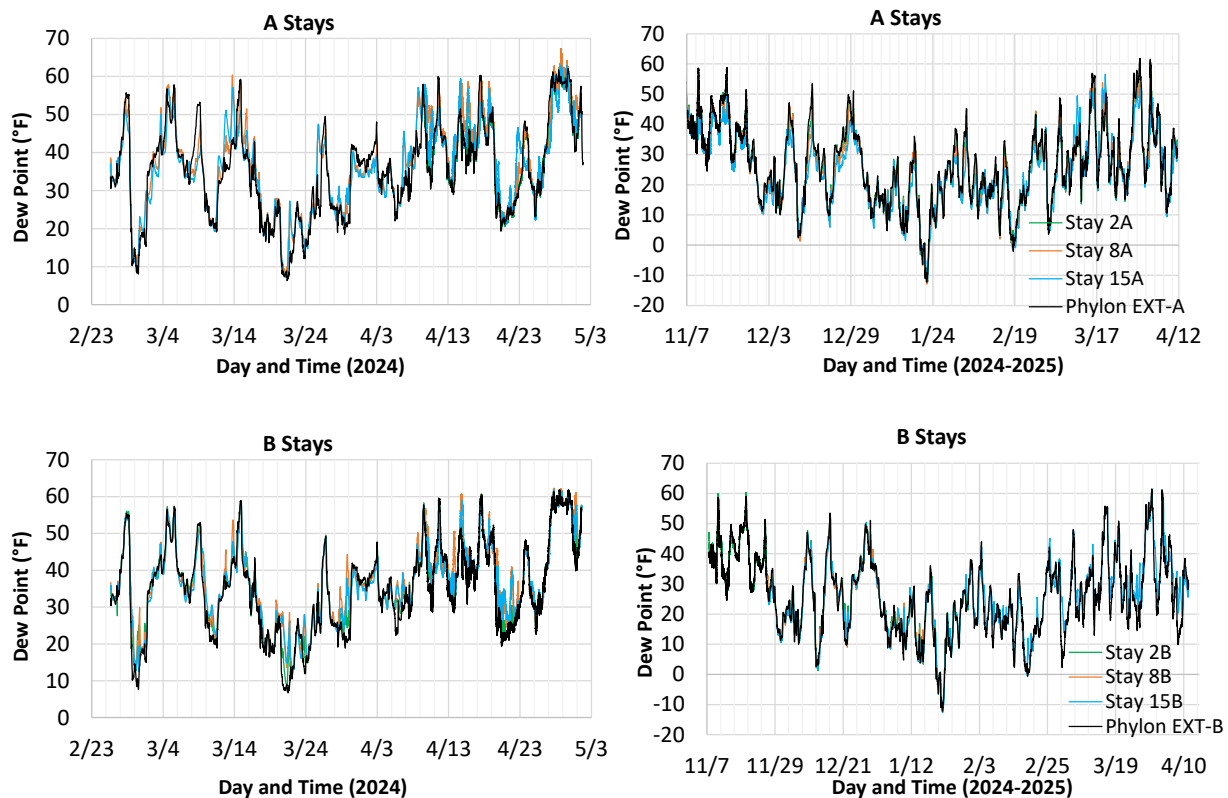
The calculated dew point (DP) data is presented in Figure 19. This calculation uses the temperature and relative humidity as input. The DP inside the stays is generally higher than the external DP, with a maximum exceedance of 20°F for the A stays and 24°F for the B stays. This indicates that the B stays have more moisture than the A stays. The maximum exceedance is generally at lower DPs, as shown in Figure 20. The overall condition of the stays may be categorized as slightly humid, according to the table in Figure 18 [10].

Figure 19 Dew point variation (calculated from the data collected).

An overall assessment of the data indicates that the conditions inside the stays are slightly more humid than the ambient (outside) conditions. There is no evidence of excessive moisture accumulation inside the stays.

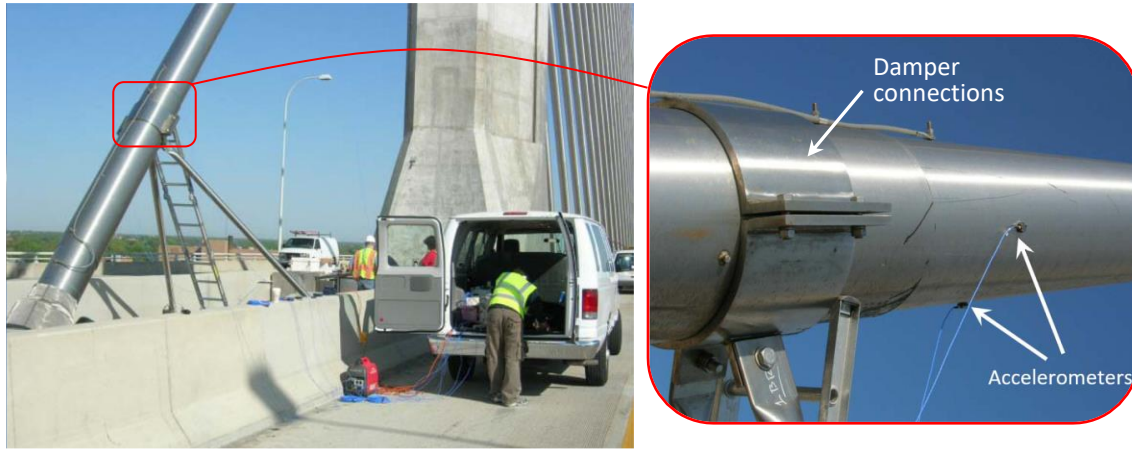
Vibration frequencies are commonly measured using accelerometers attached to stays at their lower accessible ends. This method requires the temporary installation of one to two accelerometers on a stay and recording of data for a few minutes (Figure 24 [18]). In most cases, the ambient excitation sources, such as traffic and wind induce enough vibrations, and there is no need for manual excitation. This method was applied to the VGCS after its construction and a few concerns were raised, including the interference of the dampers, and the sheathing vibrating somewhat differently than the strands at the lower ends of the stays [26].

Figure 24 Accelerometer testing performed on VGCS stays after construction.

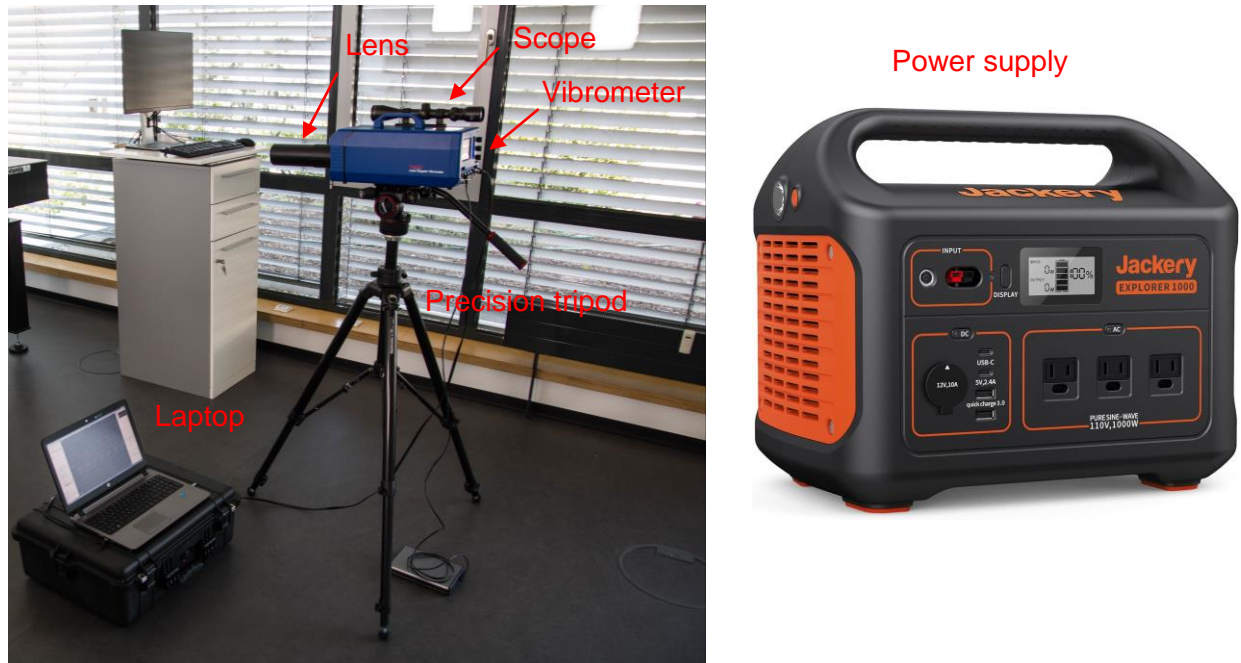
The laser vibrometer test setup used in this study is presented in Figure 26. It consists of a vibrometer, a lens, a precision tripod, a power source, and a laptop for data acquisition. The lens used in this study had a maximum range of 100 m (328 ft); other lenses were on special order (Figure 27).

Figure 26 Laser Vibrometer test setup used.

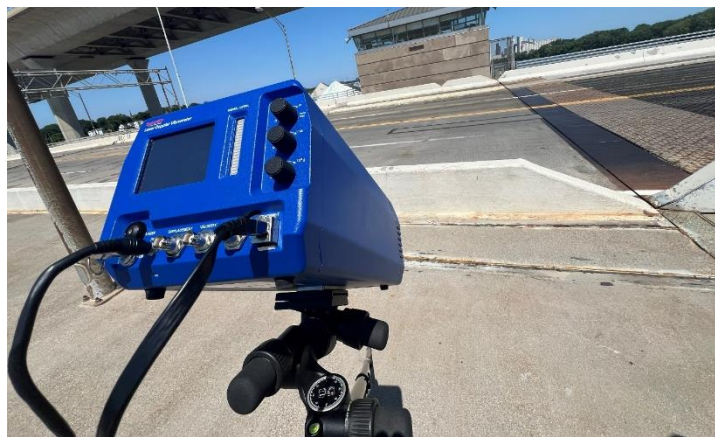
a short distance on the pavement due to bright sunlight (Figure 29) and decided to come back before dusk to test the visibility before and after the bridge illumination.

Figure 29 Invisible laser beam on the pavement.

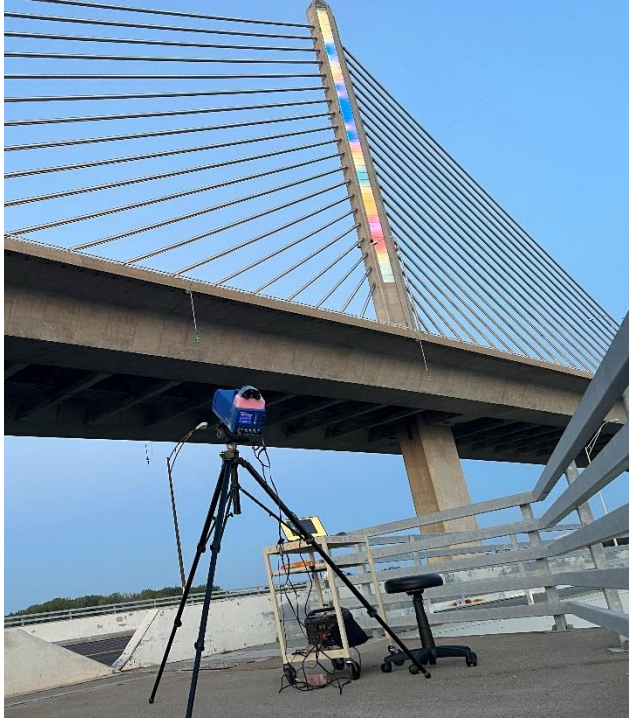
It was possible to see the laser beam both before and after the bridge illumination with the help of a pair of binoculars (Figure 30). Due to the unavailability of the scope accessory, the team temporarily installed general-purpose binoculars on the vibrometer, offset by a firm foam. The scope accessory is recommended for any subsequent measurements. The signal strength, which is a measure of the reflected laser beam that is received back by the vibrometer, was poor in all measurements (Figure 30). Possible reasons for this may be the distance that exceeded the lens range (not measured), the aiming angle that reduced the reflected signal, or a combination of both. Since the objective was to test the setup before the actual measurements from the deck of the VGCS, the measurement accuracy was not a major concern. To the surprise of the research team, however, the measured frequencies correspond very well with the baseline values, as will be discussed at the end of this section.

Figure 30 Measurements from the Robert Craig Memorial Bridge before and after dusk.

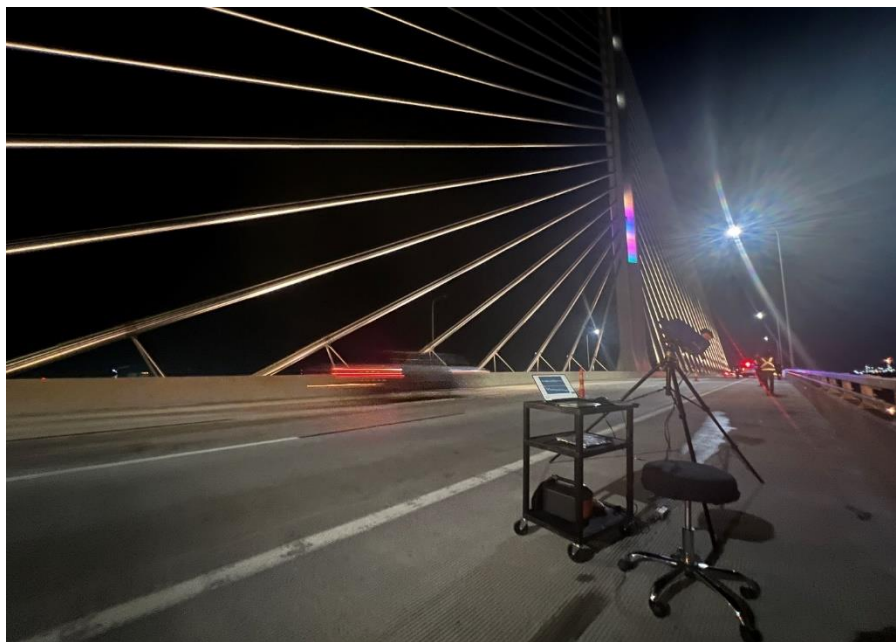
The actual measurements were taken from the deck of the VGCS on July 30, 2024. ODOT arranged the closure of the right lane to provide a suitable workspace and reduce the high-pressure shockwaves and deck vibrations associated with passing trucks. The traffic was light, and the weather was well suited to conduct site work, with 5 mph wind, and 74°F (23°C) temperature, which decreased a few degrees as the night advanced. The test setup is shown in Figure 31.

Figure 31 Test setup on the deck of VGCS at the north of the pylon.

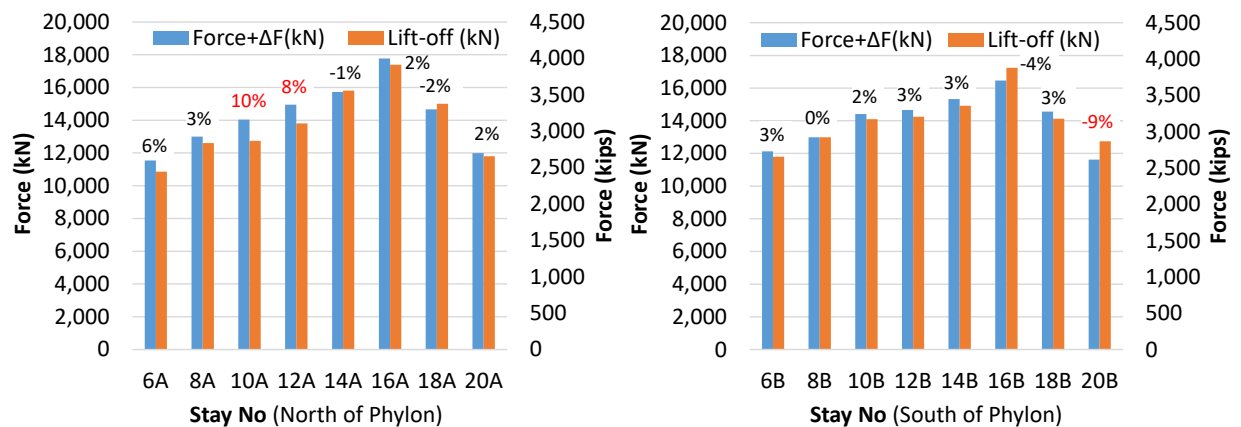
For the remaining 16 stays, the deviation of temperature-adjusted stay forces from the lift-off forces are presented in Figure 35. All deviation values are under 10%, which is within the margins of expected deviation. There are inherent errors built into the calculation and measurement procedures. The taut string equation, for example, neglects the bending stiffness of the stays. The temperature effects are considered approximate given the variable temperatures of the stays depending on their location (e.g., north or south) and sun or shade conditions. The laser vibrometer measurement method may introduce $\pm 1\%$ error, which corresponds to $\pm 2\%$ error in the estimated stay forces (Mehrabi and Farhangdoust 2018). The lift-off values may also have minor errors involved. Consequently, the results do not warrant a credible concern for the health of the strands.

Figure 35 Comparison of the calculated stay forces with lift-off forces at the same temperature.

While within the margins of expected deviation, the 10% and 8% overestimation of Stays 10A and 12A indicate a need to monitor this area in the next measurement cycle. If, at that time, the force in Stay 11A (not measured in this study) is found notable below its

lift-off value, this may indicate a concern. A common pattern for potential damage includes a stay losing its tension and two adjacent stays gaining tension. The 9% deviation measured for Stay 20B is less of a concern, given that the Stay 19 measurement from Robert Craig Memorial Bridge also has a deviation in the same direction.

Considering the results obtained and the error margins built into the procedures, no credible concern is detected for the health of the stay cables of the VGCS. It is recommended that a re-measurement study is undertaken in 4 years with closer attention to Stays 10A-11A-12A and 18B-19B-20B. Laser vibrometer measurements from the Robert Craig Memorial Bridge may be considered at that time if an extra-long-range lens and proper aiming equipment could be secured. This may eliminate the need to close a lane of the VGCS. In addition, measurements could be split into two nights for a longer duration and multiple rounds of recordings.
