Senior Design Project

Final Report

The University of Toledo Ottawa River Restoration

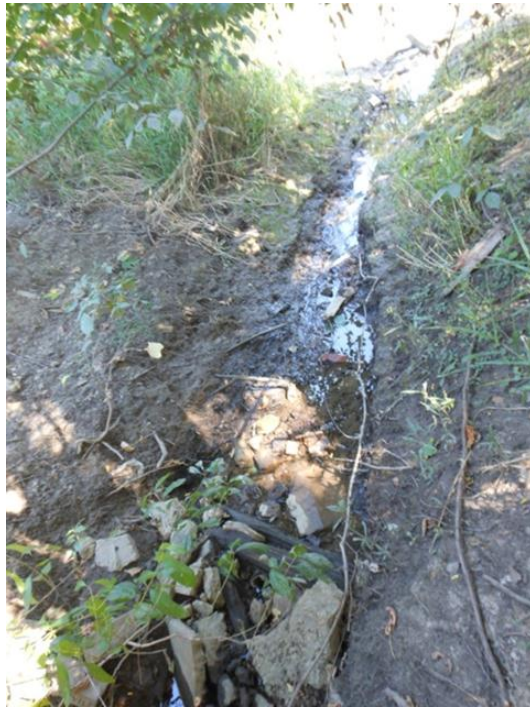
Figure 18 – Outfall #3 Channel

The concrete pipe in the headwall has no damage and has accessible flow into the channel. The channel consists of a small path worn into the soil from the small flow of water. The concrete headwall is in relatively good shape. The headwall extends out of the ground significantly due to erosion caused by the removal of the various trees and bushes that were originally around the outfall (Figure 9). The massive headwall is no longer needed due to the erosion issues. The headwall is also currently leaning forward. There is no form of channel stabilization to restrict the flow path of the water.

The best location for these rock check dams to be used would be Outfall #3 and Outfall #4. The reason for this is that these outfalls have a relatively long channel, as compared to the other outfalls, extending from the headwall to the edge of the river. The channels for Outfalls #3 and #4 can be seen in Figure 18 and Figure 19 respectively. This would provide enough room for check dams to be installed for each outfall so that there is no further erosion of the existing bank due to these storm water outlets. Picture 4 in Appendix B shows how rock check dams could be implemented in these channels.

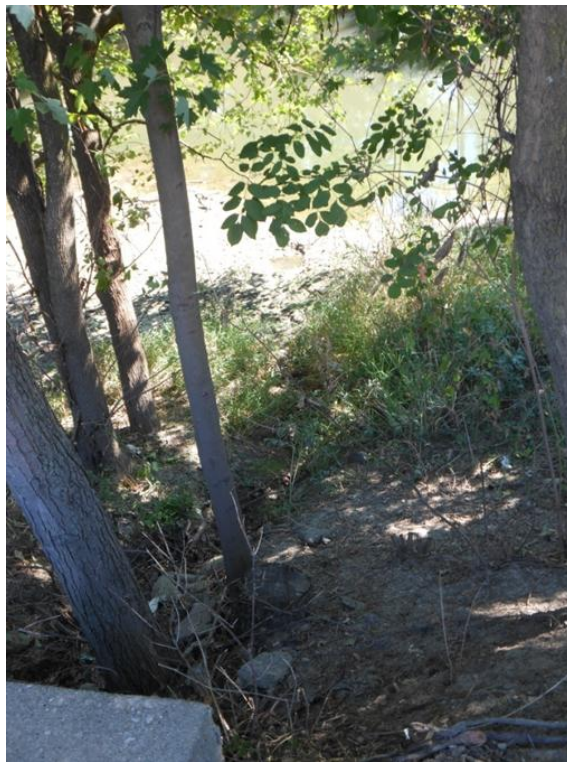
Figure 19- Outfall #4 Channel

Outfall #4 is located in Reach 5 on the North side of the Ottawa River, South of the Health and Human Services Building. This outfall sits 8 feet south of the curb along North Towerview Boulevard. Outfall #4 is in poor condition. Inside the headwall, the pipe had settled, disconnecting itself from the headwall. As a result, the pipe no longer lines up with the headwall's outlet as shown in Figure 11. Soil on the top side of the headwall has, overtime washed out due to the separated pipe carrying the earth away and exposed the back side of the headwall. There is severe erosion along the side of the headwall as well, due to poor bank stabilization as seen in Figure 12. Outfall #4 does have a long channel, compared to other outfalls, that has a relatively flat slope as it approaches the main flow area of the river. The channel could also use protection from erosion, since the channel walls have little vegetation to control the erosion. The current headwall is a U-shaped structure with the dimensions of 70" tall, 60" wide and 35" deep. The pipe inside the structure has a 12" diameter

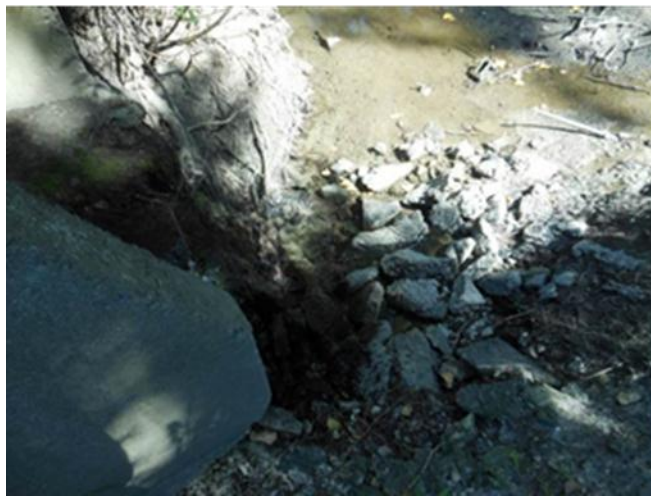
Figure 22 – Outfall #1 Channel

Outfall #1 is located in Reach 3 on the North side of the Ottawa River, between the pedestrian bridges by the Center for Performing Arts and the Carlson Library, just off the access path. There is no vegetation where this outfall is located. There is little damage to the headwall itself, but soil has eroded from underneath the headwall structure on its western side. Also, the splash pad has broken off on the westernmost side of the outfall. The erosion has caused some of the toe of the headwall to break away (Figure 3). Outfall #1 has steep banks that lack stability resulting in the erosion. The outfall does not have a very lengthy channel run. There is rip-rap at the base of the outfall, but there is little protection of the banks around the outfall. Dimensions of the current headwall are 67” tall, 82” wide, and 36” deep. This outfall utilizes a 14” diameter pipe.

Outfall #5. Figures 22, 23, and 24 depict these outfall channels. Picture 5 in Appendix B shows how A-Jacks could be implemented in these smaller channels.

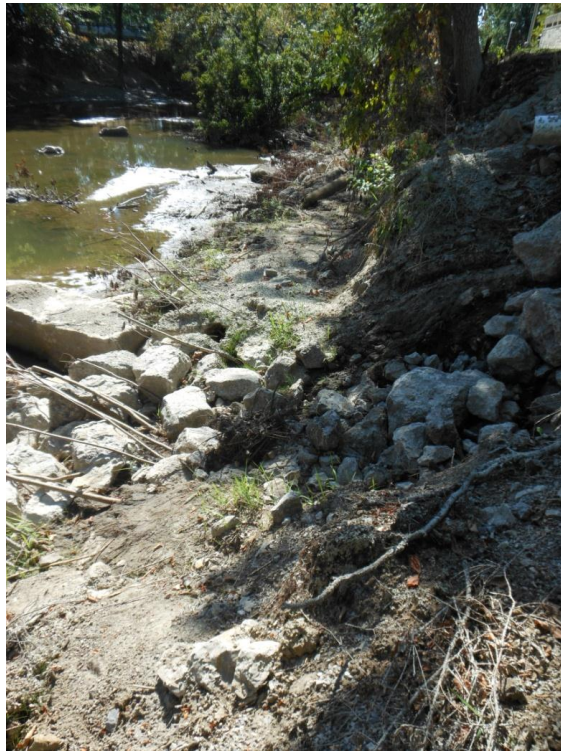
Figure 23- Outfall #2 Channel

The concrete headwall seems to be in working condition. It is serving its purpose of holding back the earth around it. The corrugated metal pipe has been damaged, presumably from recent construction work performed during the river restoration (Figure 6). The channel consists of eroded soil on the banks with various sizes of rocks in the middle of the channel to help dissipate the flow with the large elevation difference between the outfall and the water level.

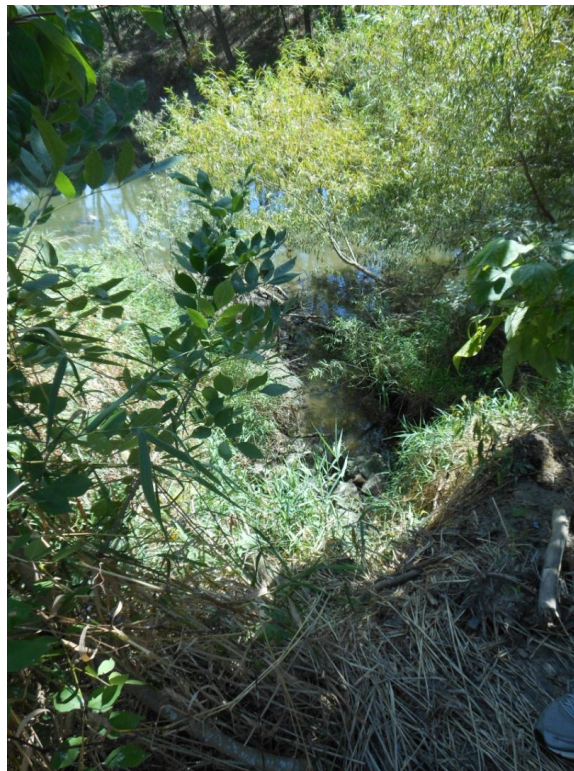
Figure 24 – Outfall #5 Channel

Outfall #5 is located in Reach 5. This outfall has a 21" pipe and a 37.5" tall headwall. The headwall and splash pad to the outfall are in good shape, but there are erosion issues due to poor bank stability in the channel. This head wall also contains a flap gate which prevents the river water to backflow into the pipe. Soil on each side of the headwall is loose and is eroding into the channel as shown in Figure 14. Outfall #5 has a relatively long flow channel that will also require erosion protection. Figure 15 shows the channel at Outfall #5. The eroding issues with this outfall are simple to correct.

The existing headwall at Outfall #5 is still in very good condition. There are no noticeable issues that would justify any repairs or the replacement for this headwall. The only concerns for this outfall reside in the channel erosion.
