# **Strengthening of Bridge Columns Subjected to an Impact Lateral Load Caused by Vehicle Collision**

## **Phase I Final Report**

**PI: Azadeh Parvin, D.Sc.  
Associate Professor  
Department of Civil Engineering  
College of Engineering**

**August 2011**

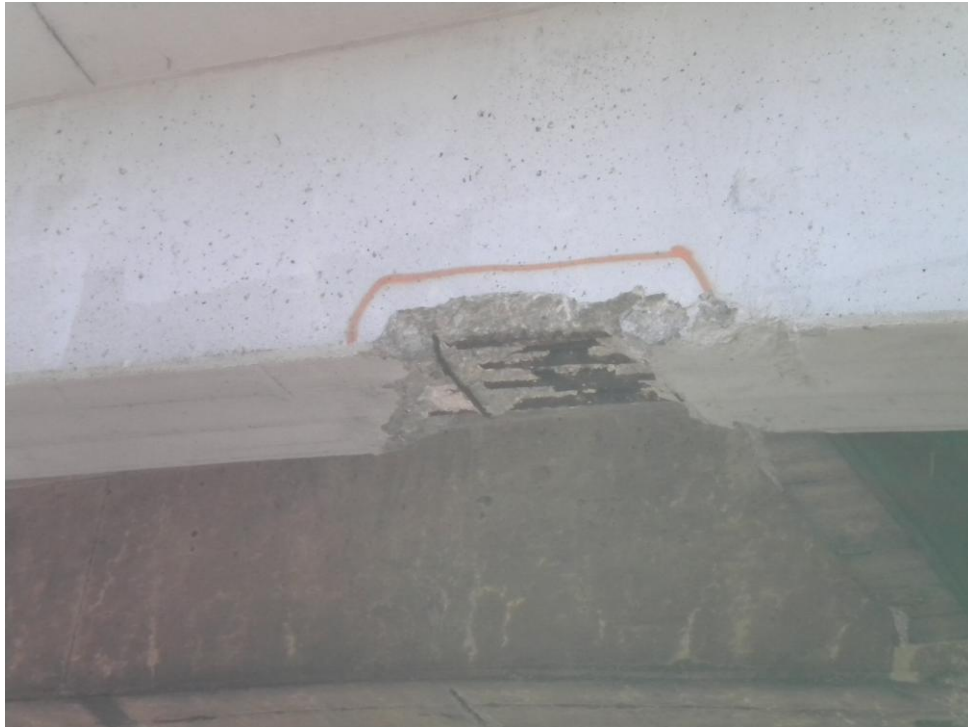
**Fig. 1.** Damage Caused by Overheight Vehicle Collision

from vehicular collision damage. The damage caused by such impacts can lead to concrete cover spalling or cracking, reinforcement damage or exposure, or in worst cases, structural failure. Fig. 1 shows damage caused by an overheight vehicle striking a bridge girder.
